RICS **Building Survey**...

Date of inspection

09 November 2017

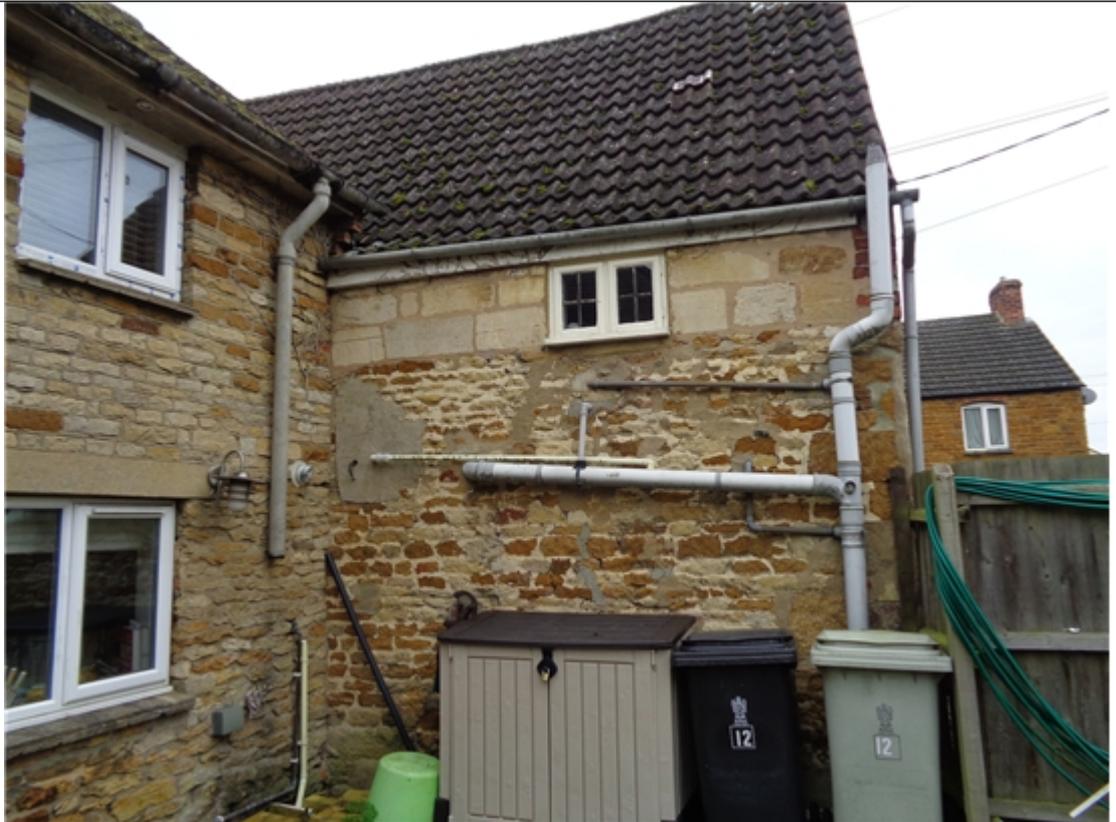
rear elevation, roof showing bathroom vent outlet

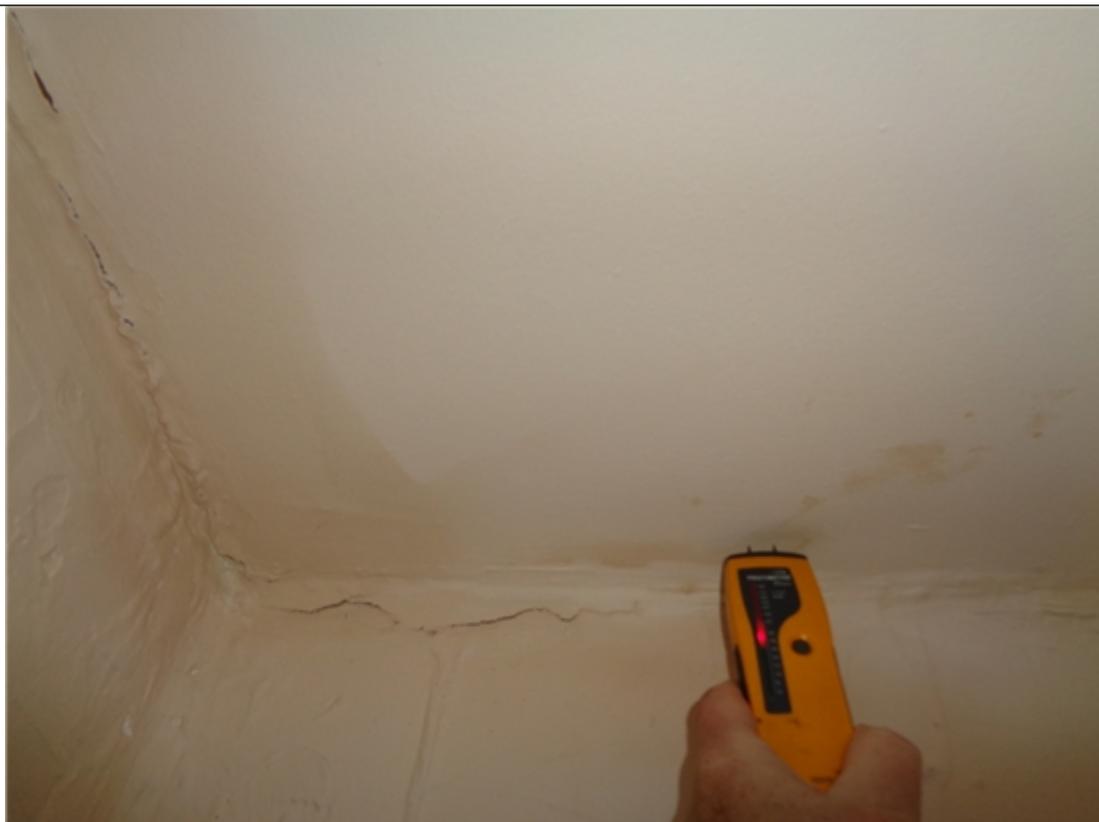
Tape and mortar flashing around its base are old/defective. They should be renewed. Dampness stains mixed with tar deposits from previous coal use are visible in the left-hand bedroom and bathroom where the décor has discoloured and which register damp on the moisture meter. These relate to dampness penetrating down and around the chimney.

damp and tar stains in bedroom by chimney breast

The plaster and paintwork internally will need partial replacement and sealing. The flue should be properly ventilated and lined if further investigation by your contractor identifies it is required. A cowl should be fitted to the chimney pot to help avoid rainwater penetration.

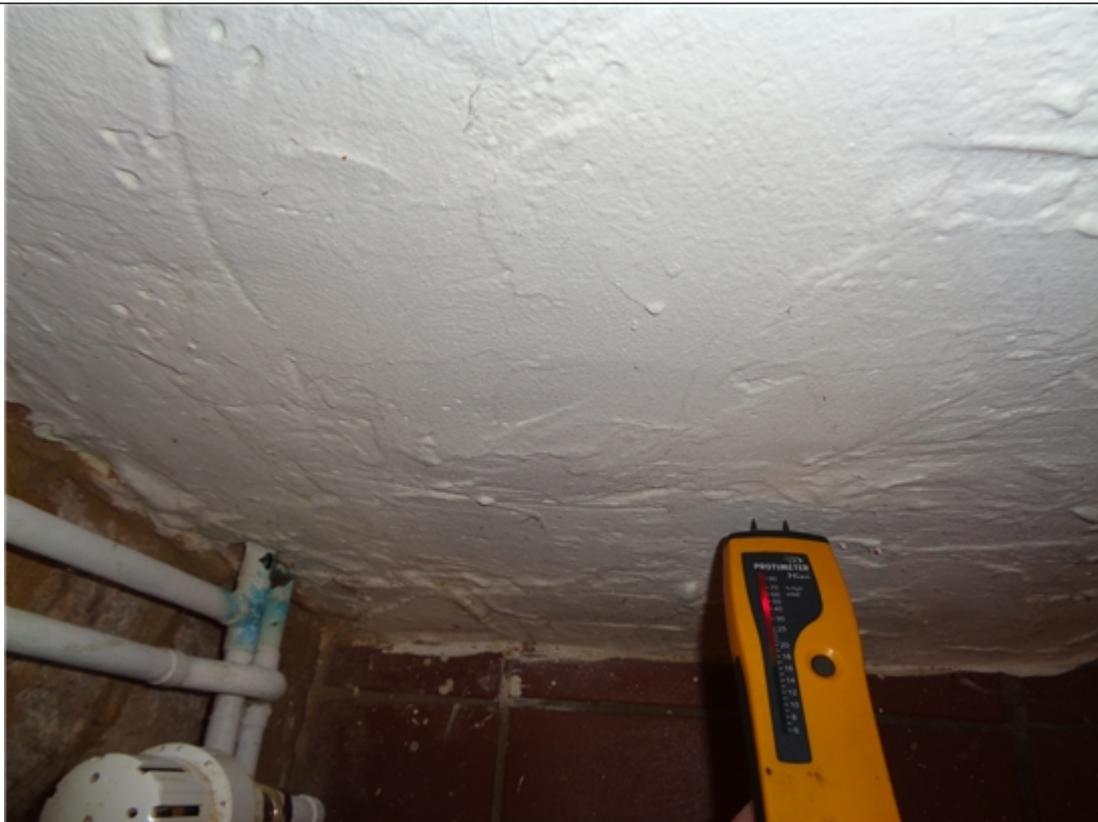
Rising damp was recorded on the moisture meter in most accessible ground floor walls apart from the right-hand wall in the kitchen. This is not unusual in an older property. Over time it can damage the building fabric and be a health risk. You should employ a reputable damp proofing contractor to provide a report and quotation for necessary repair works. This will probably entail chemical injection of the walls under pressure followed by related internal replastering and redecoration. You should obtain a comprehensive insurance backed guarantee for all such work undertaken.

damp meter reading in kitchen

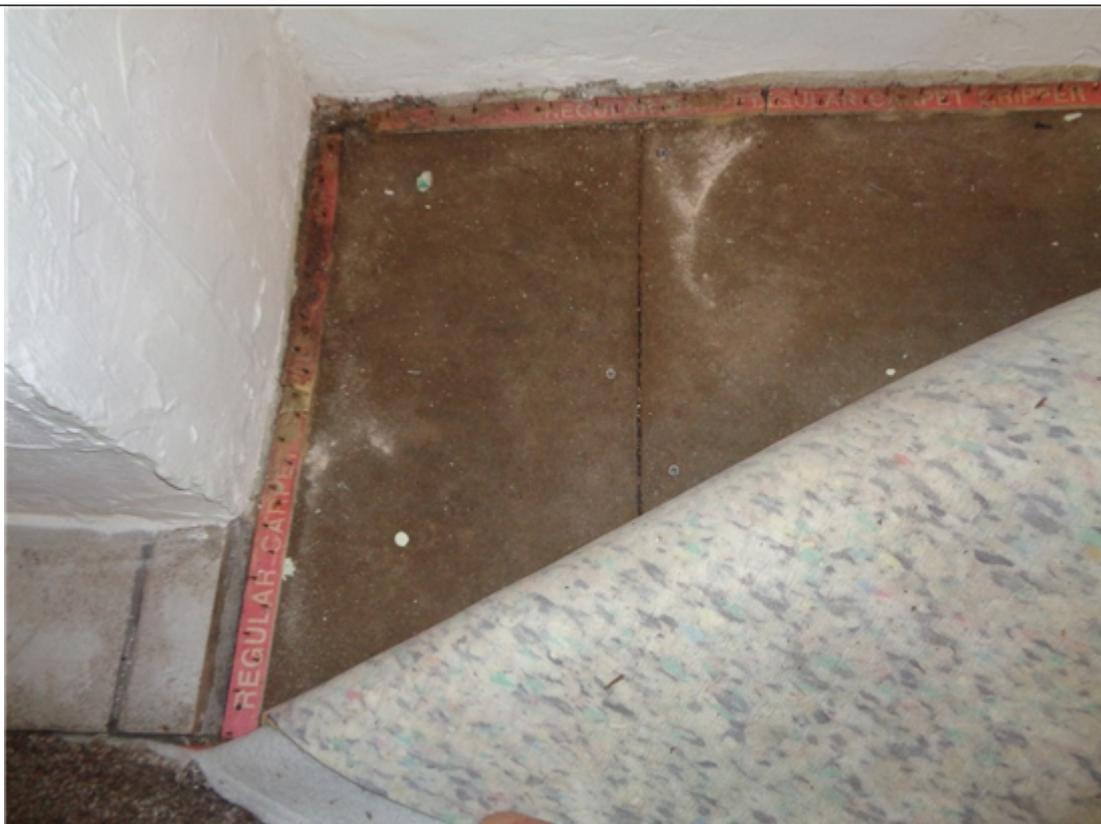
Whilst it feels level and sound underfoot it may be that upon removal of carpets and hard board the floor is old with no damp membrane. If this is so (e.g. brickwork, older style quarry tiles etc) then it should either be replaced with a concrete screed over a damp-proof membrane or coated with bitumen to provide a level surface and effective damp-proof membrane.

hardboard floor finish in lounge

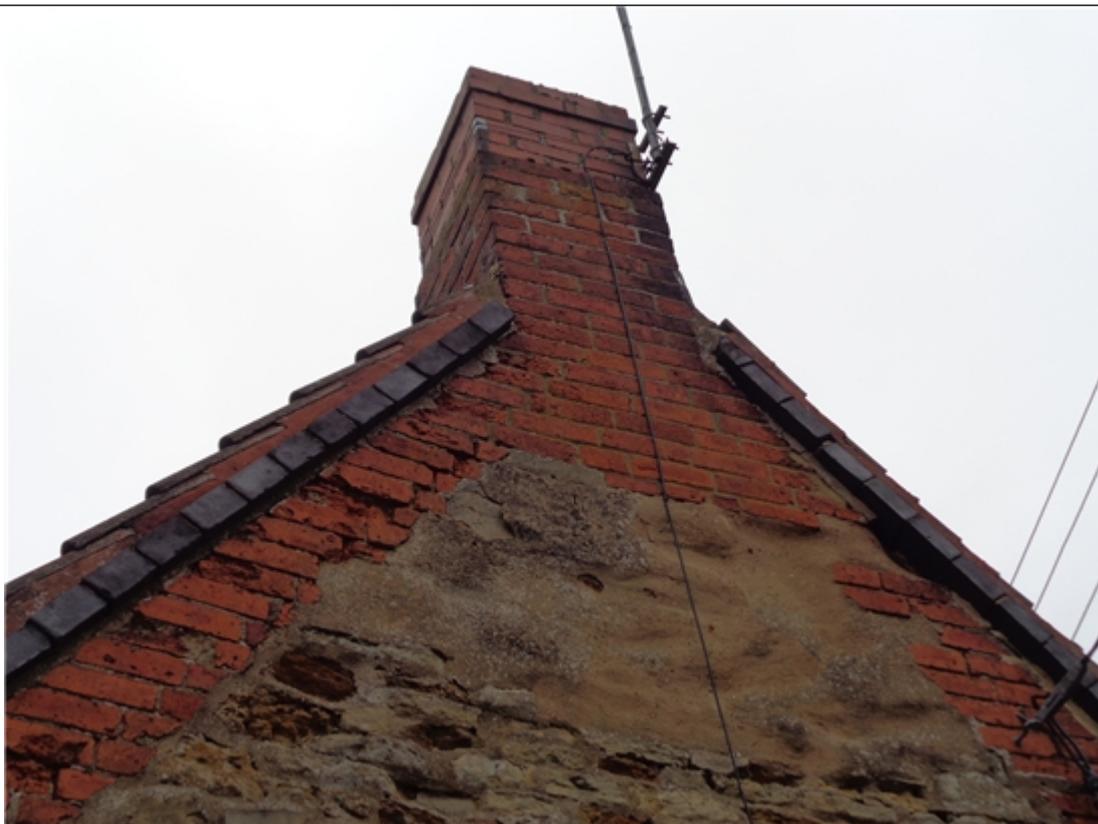
There are sections of brickwork visible to both side elevations. This and the differing nature of stonework below eaves to the front and rear indicate the roof has been heightened in the past and that the property originally probably had a thatched roof covering. The brickwork is weathered and stained to both sides, particularly the left-hand elevation. It should be repointed and the most badly affected bricks should be cut out and replaced.

perished brickwork to left gable wall

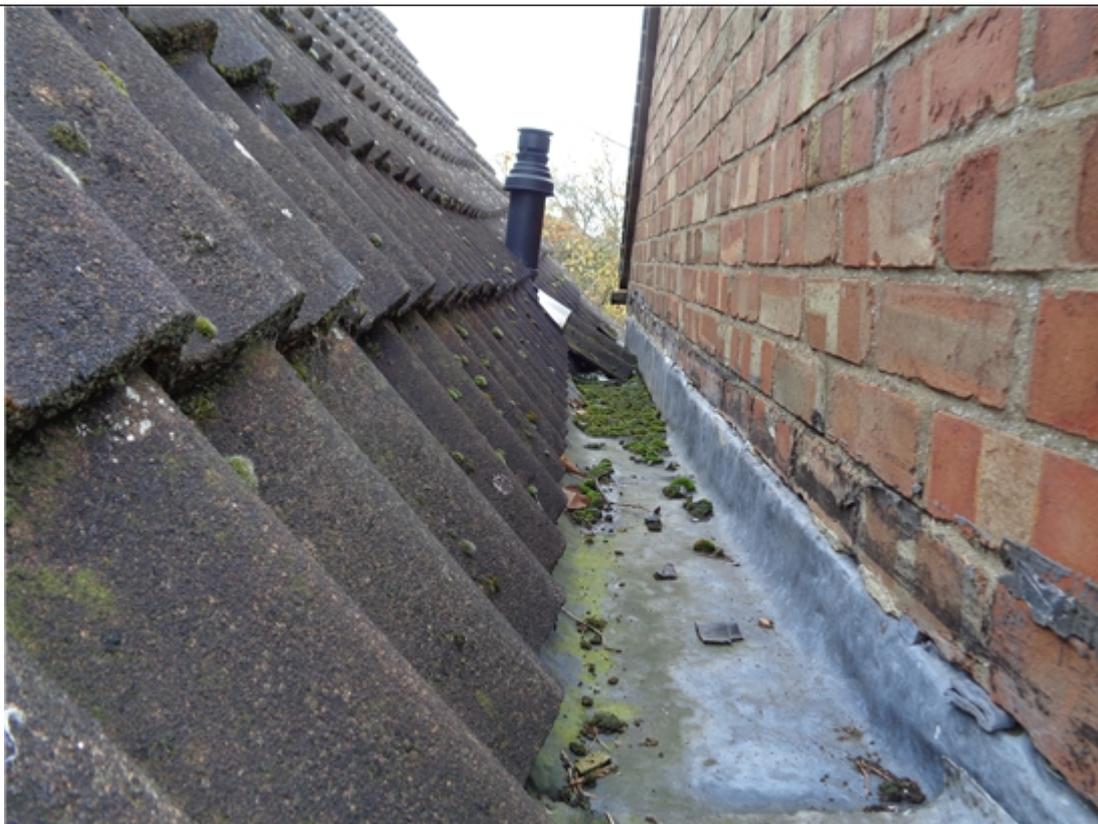
Such valleys pose problems with water penetration due to either defective design or to blockage (for example by leaves). This valley has moss accumulation in it. The leadwork where it meets No.12 is loosening. Stains on brickwork and stonework to the right-hand elevation suggest the valley is leaking. There is a builders bucket in the roof space close to the rear valley suggesting previous rainwater penetration into the roof space.

view of roof valley adjoining number 12 to rear

Periodic inspections and clearing out are then recommended. Moisture penetration can cause dry rot and damaged plasterwork/decorations.

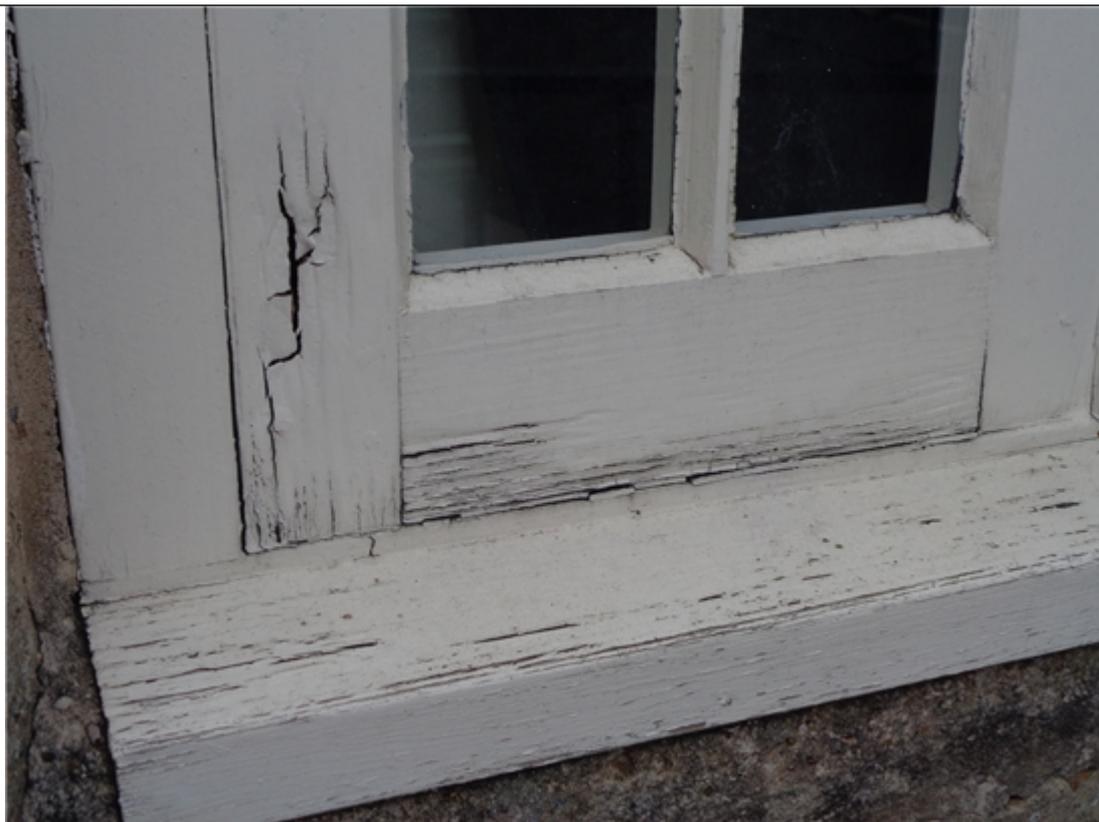
The windows are in serviceable condition. The lounge window to the left elevation is rotting. It should be repaired or replaced by a competent joiner. It is suspected the bathroom window to the rear may be similarly affected and also require repair or replacement.

wet rot to lounge side window

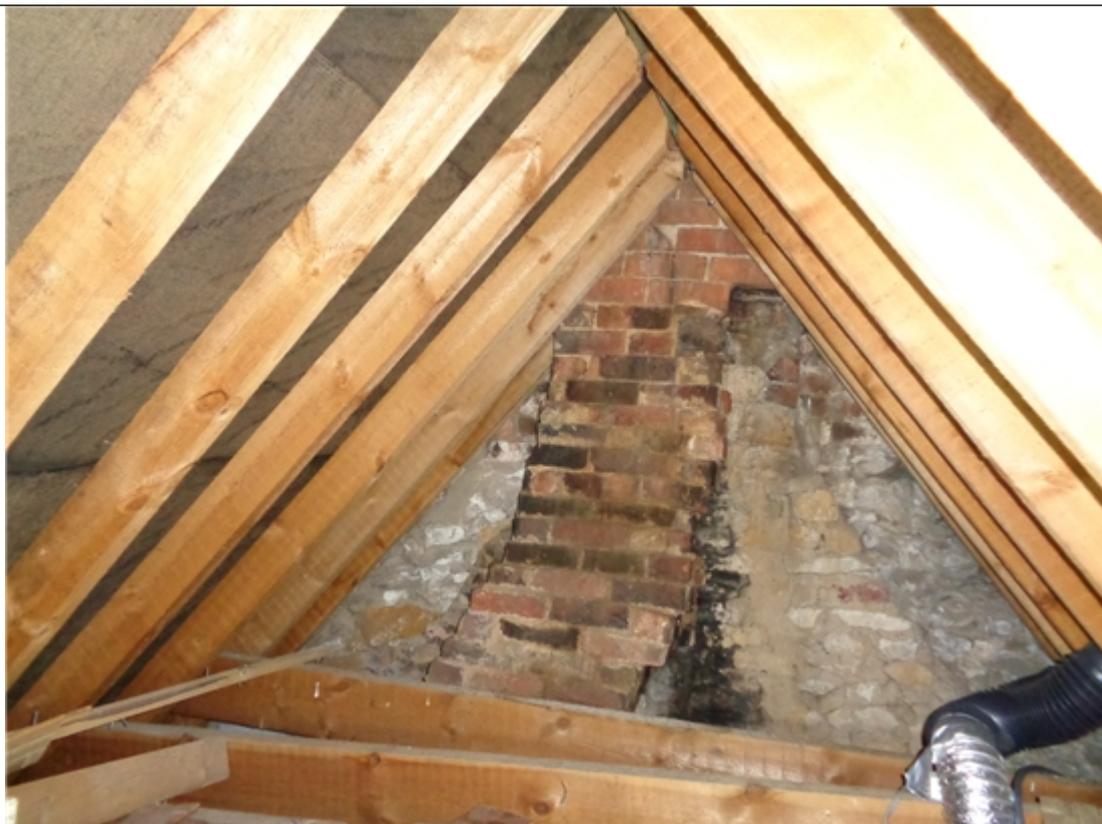
The original timber cruck frame remains in the roof space. The frame has otherwise been replaced by a substantial timber frame of down rafters and cross purlins which are cross braced from front to rear above first floor ceiling level. No evidence of significant defects is apparent. The cross bracing should retain the structure following the roof spread reported in E2.

attic looking left showing new timber frame and tar stains on chimney breasts

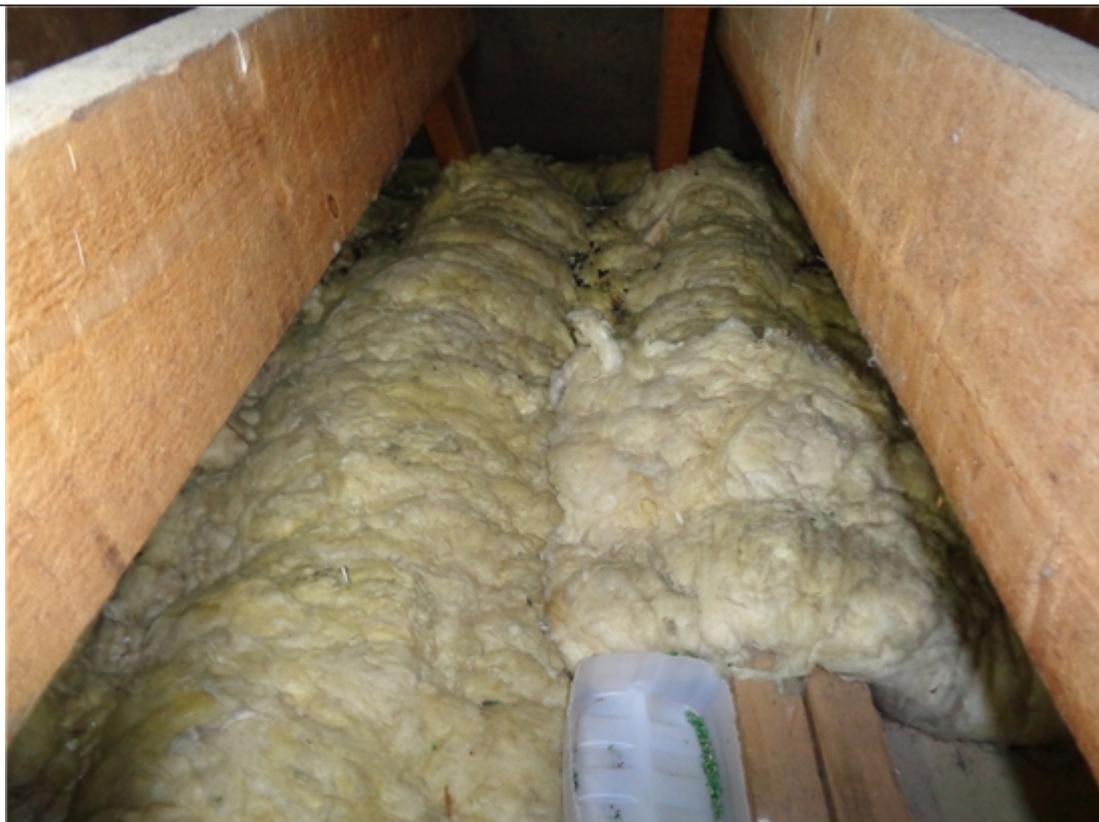
There is evidence of vermin droppings in the roof space, next to the central heating boiler and in the kitchen where bait and traps have been laid. Mice, rats and squirrels can cause damage, particularly if they chew through electric cables. You should employ a pest control officer to inspect and lay rodent bait etc as necessary. Services should be checked. Please see Section G.

rodent bait and droppings in roof space
