RICS
Condition Report

Date of inspection

25 April 2015

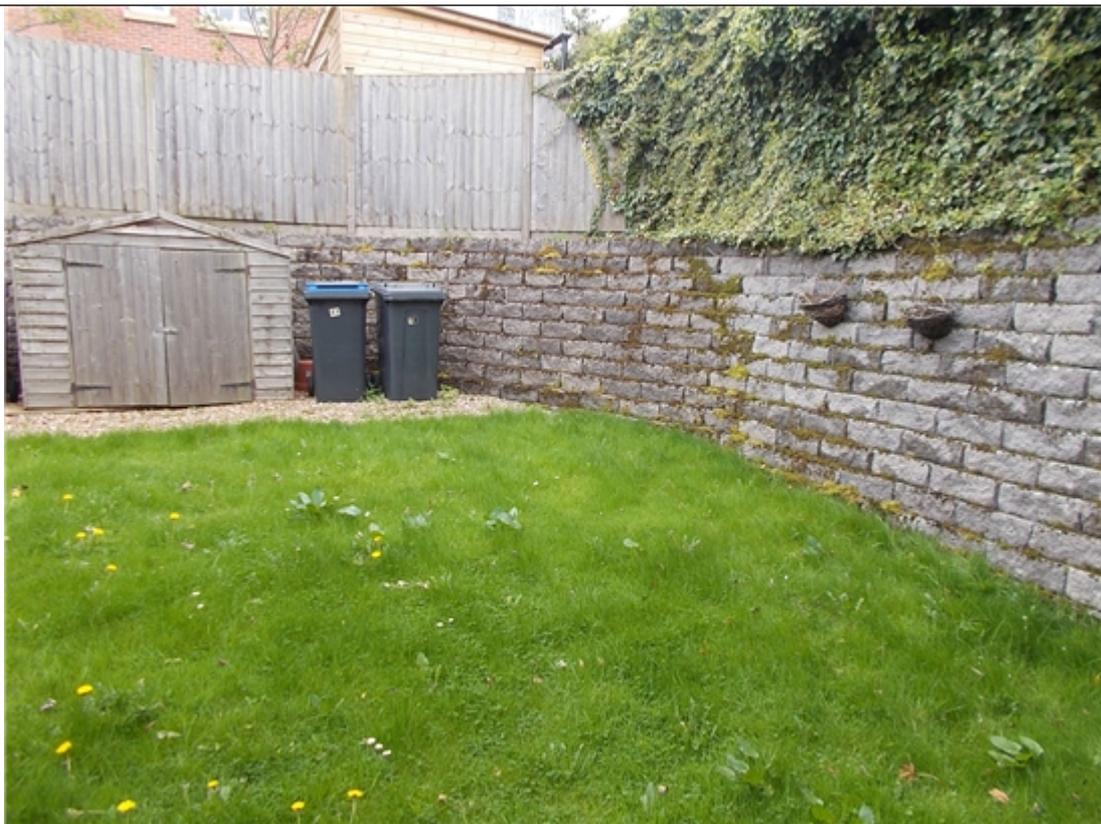
There is a retaining wall to the rear garden built of stone blocks and which is about two metres high. Such walls restrain considerable weight behind them. They often become damp and start to deteriorate/lean. They can fail without warning and be costly to repair or replace. The wall is becoming mossy.

Garden retaining wall

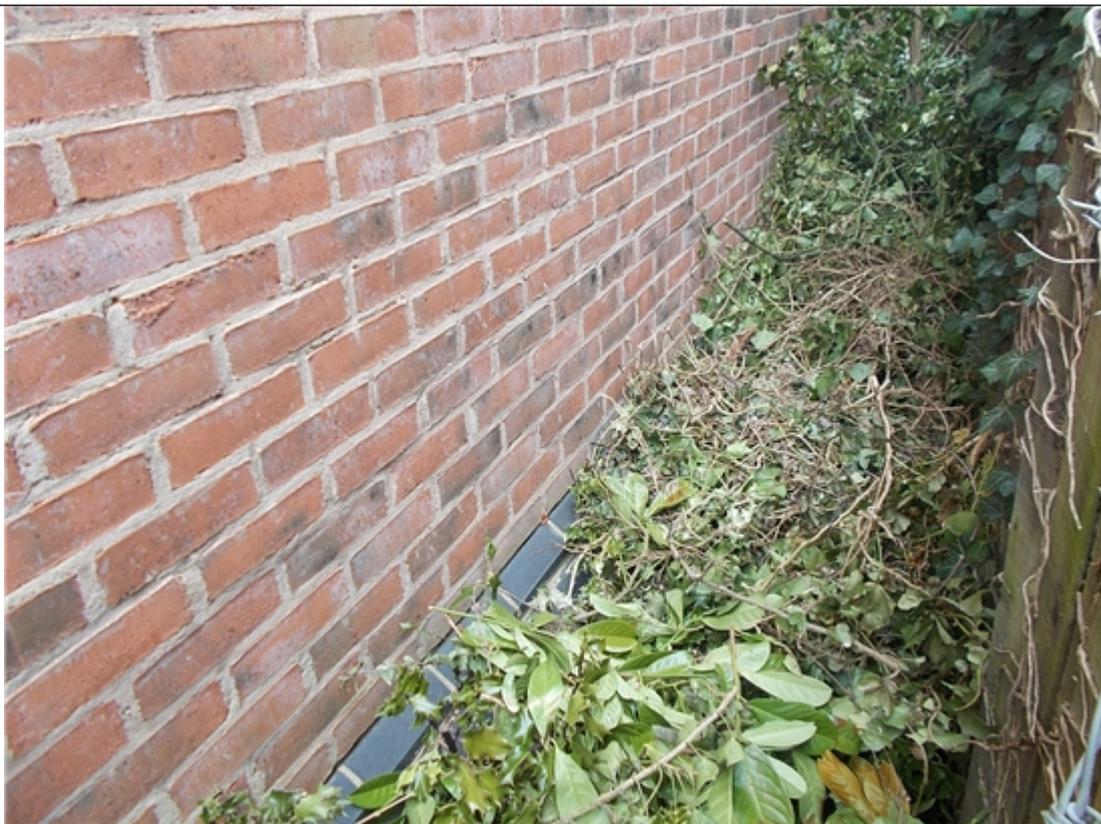
High ground level to right hand side

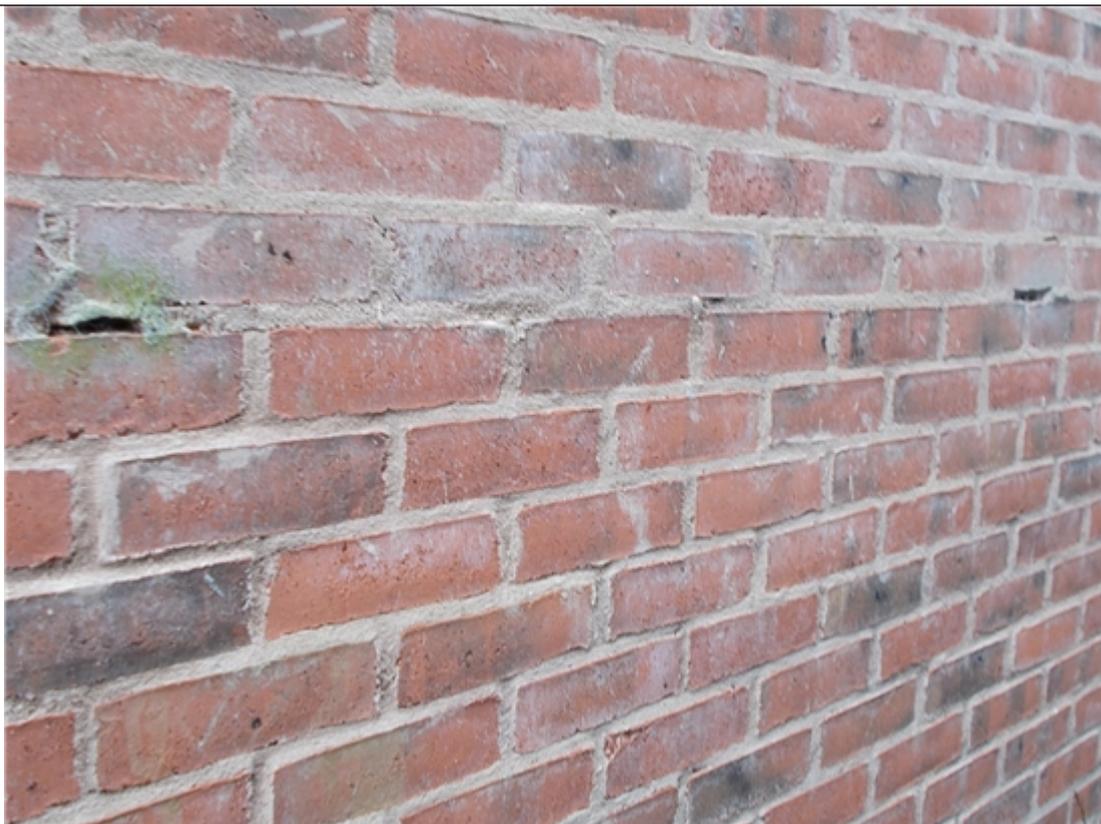
The wall surfaces are in satisfactory overall condition although the mortar pointing finish is untidy in places, eg. to the right hand elevation.. There are three or four gaps in mortar joints to the right hand elevation which have not been filled following removal of the original scaffolding poles.

Open mortar joints and untidy cement pointing to right hand side

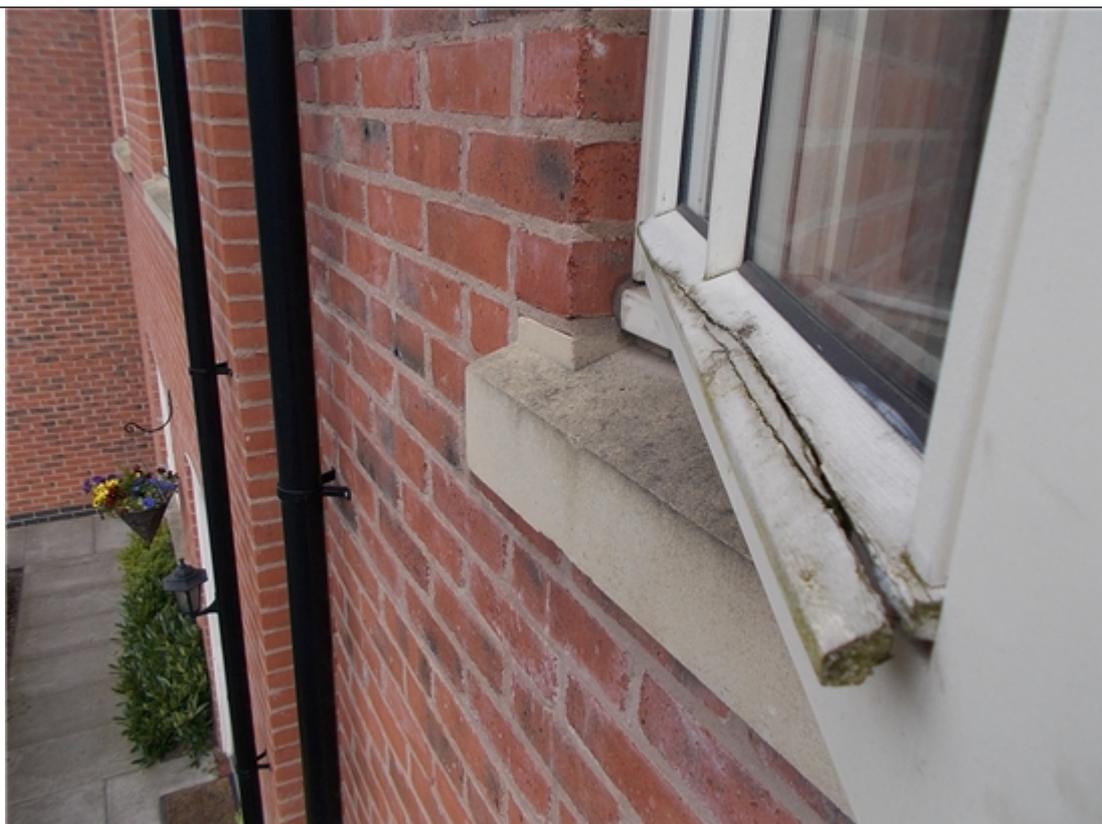
The fittings are in generally serviceable condition although beading across the bottom of the front left bedroom window frame is split.

Split window frame

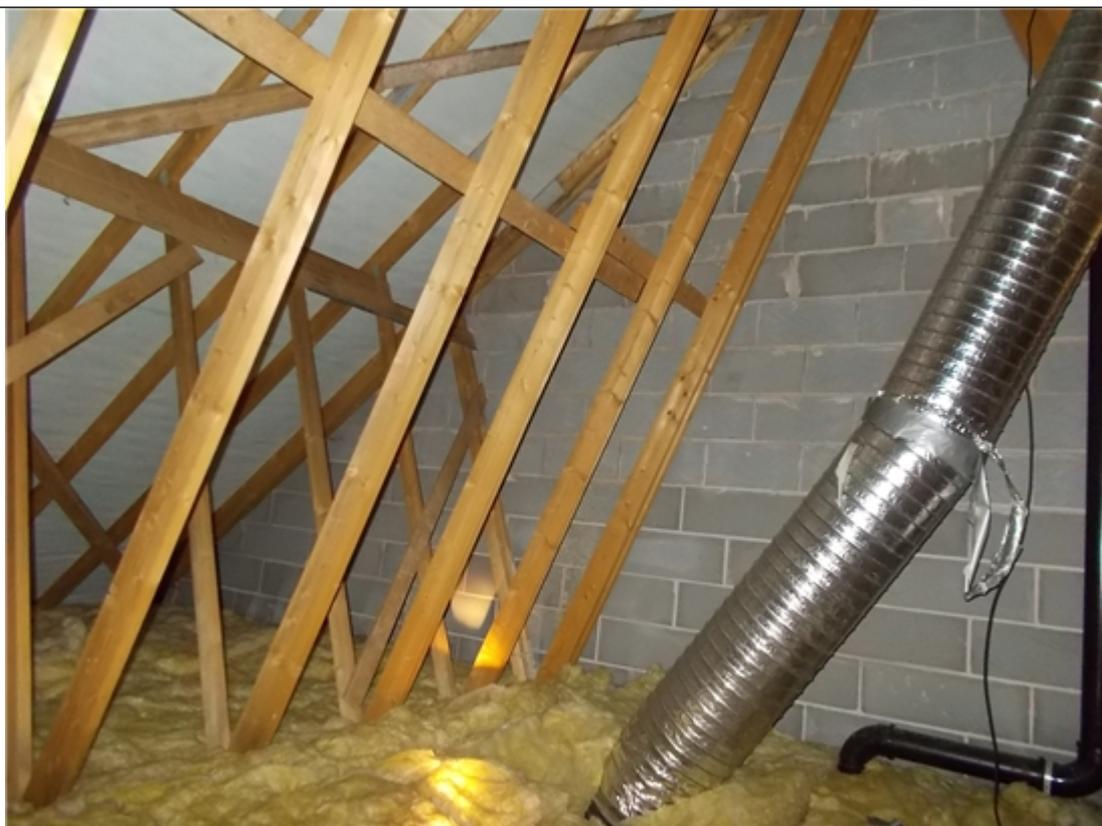
The roof covering is supported by a timber frame of trussed down rafters which are cross braced. . No evidence of significant defects is apparent. There is a good depth layer of fibre glass laid across the ceilings.

The loose foil wrapping/cover around one of the solar tubes in the roof space should be refixed (see photograph at end).
