RICS  
**HomeBuyer** Report

Date of inspection

25 February 2015

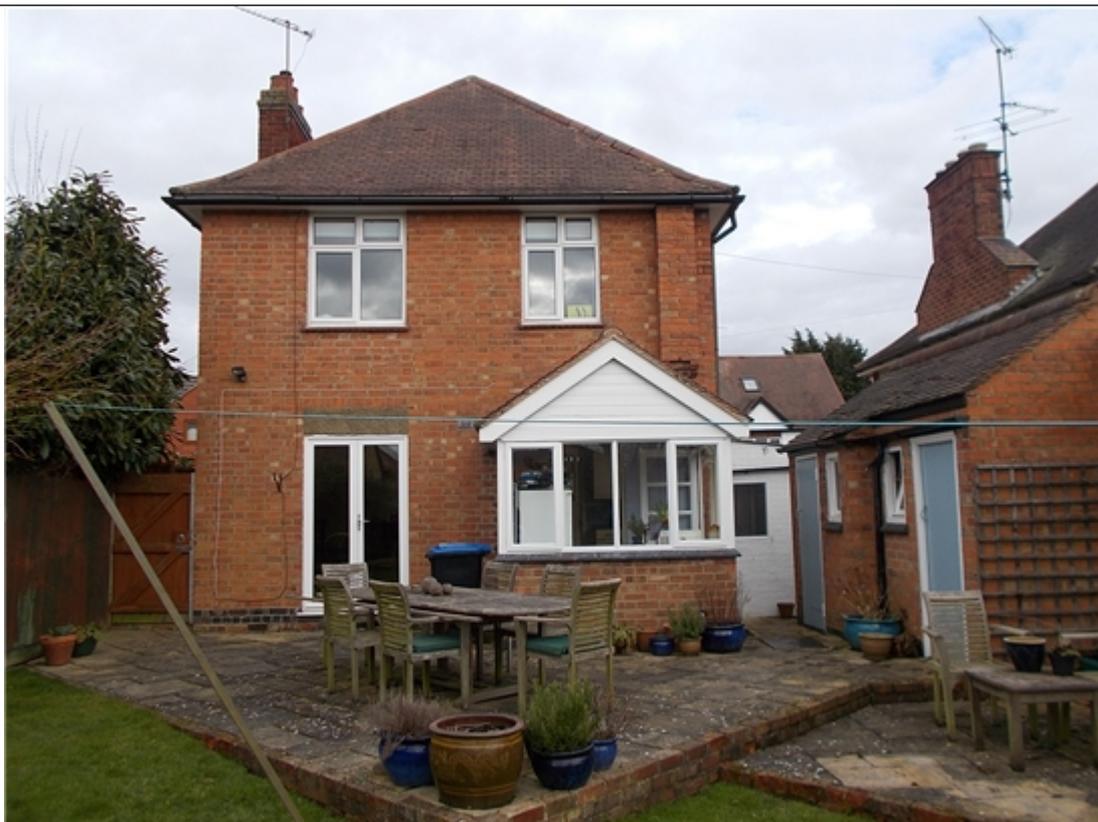
Rear elevation showing nearby Laurel bush

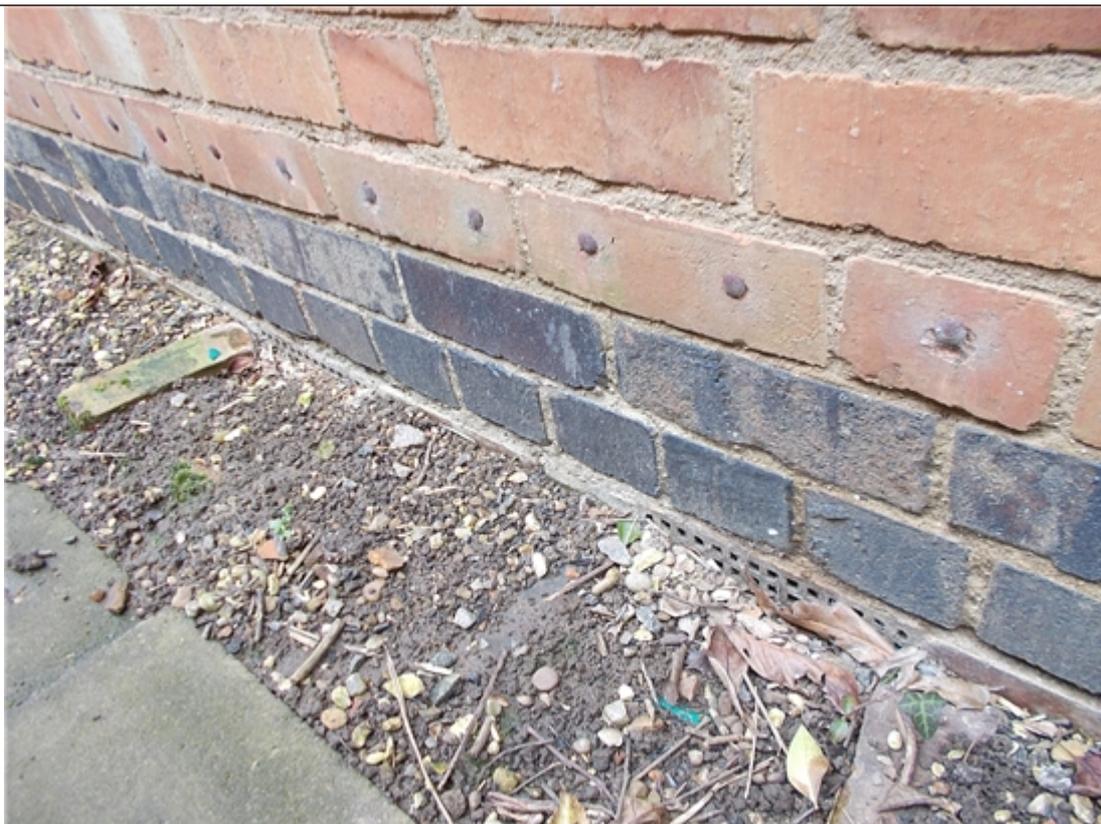
The floors in the living rooms are of suspended board on timber joist construction. No evidence of significant defect was found and air bricks through the outside walls appear to be sufficient to ventilate the under floor spaces. Those to the front and rear are clear. The two to the right are becoming blocked and should be opened up.

Blocked airbricks to right hand side

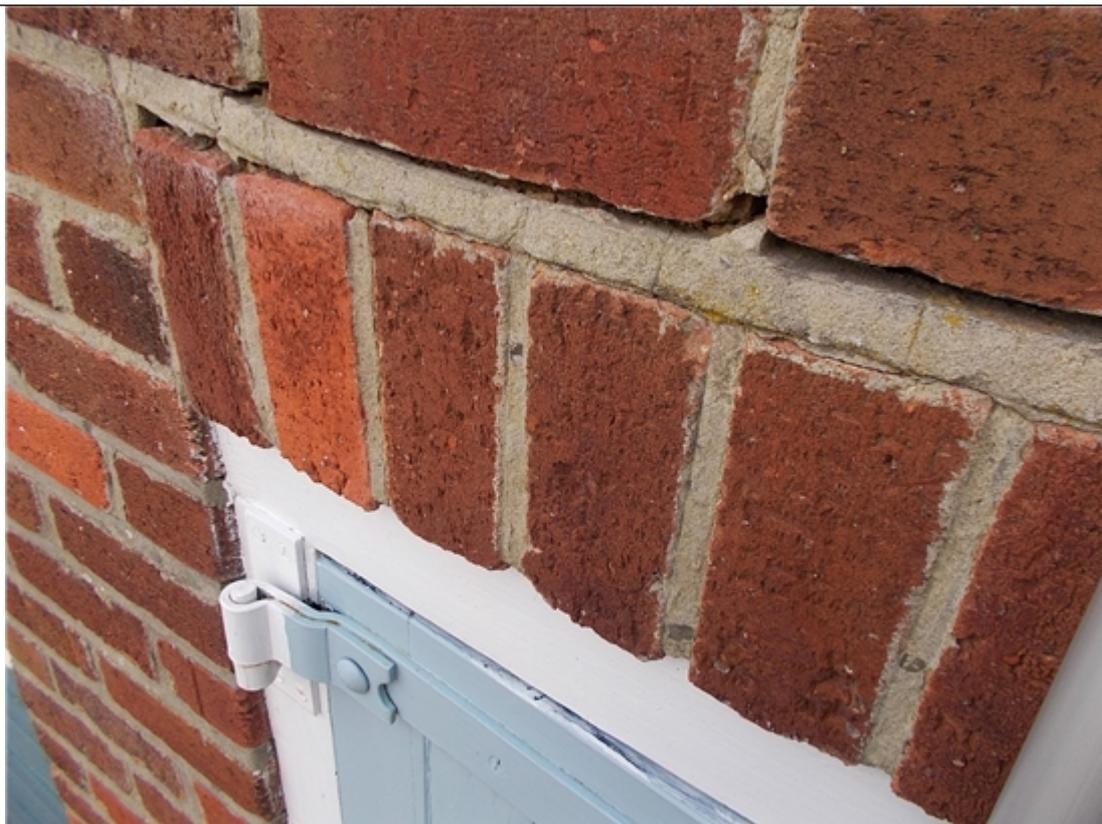
Cracking over garage front door

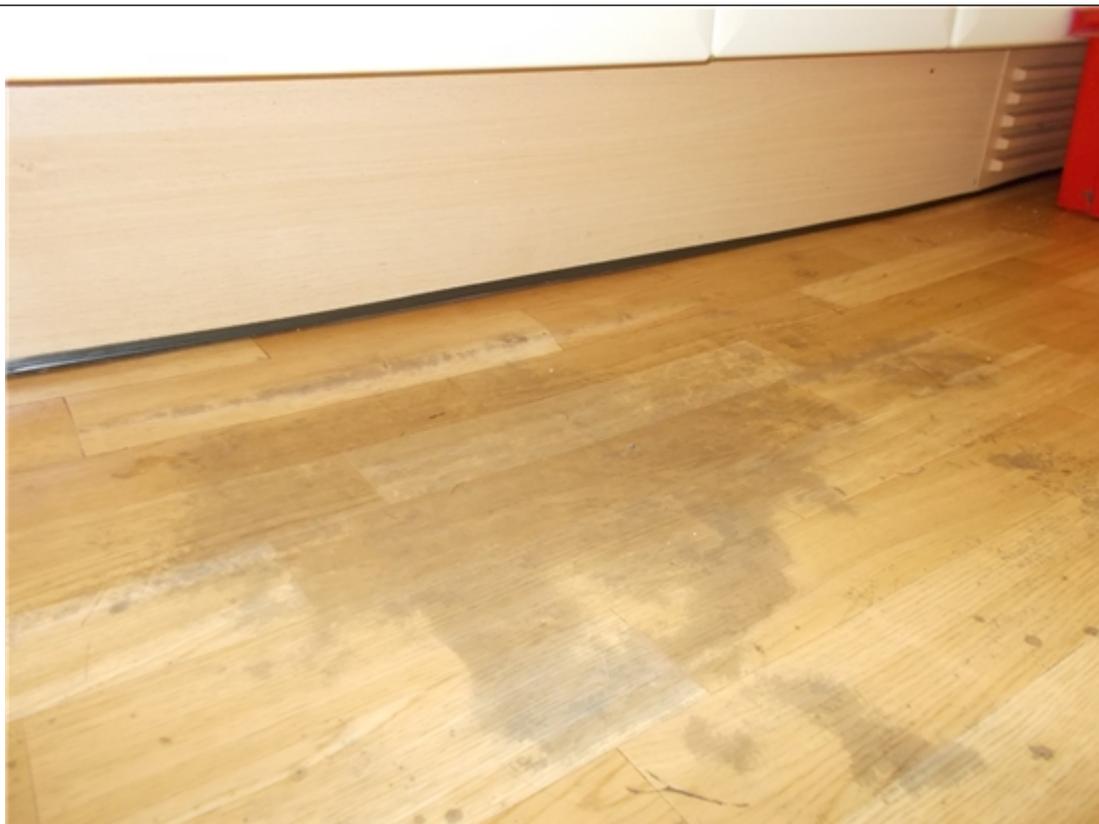
Disappointingly, it was not replaced/levelled when the kitchen was refitted. At a future date this work will be probably be needed, possibly using mastic asphalt to provide a level surface and effective damp proof membrane.

Damp and uneven kitchen floor

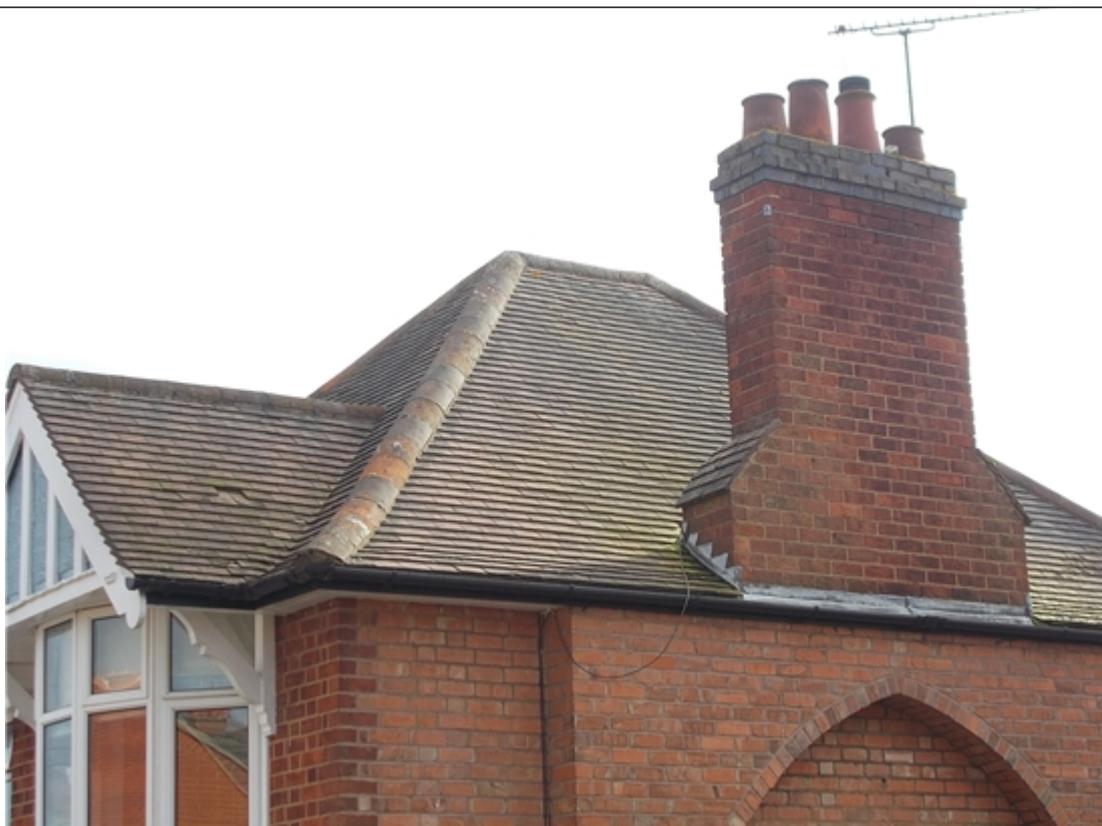
It is in satisfactory condition allowing for normal weathering over the lifetime of the building. The top six or so courses of mortar joints are weathered and moss affected. They should be raked out and repointed by a competent builder.

The mortar pointing to the ridge and hip tiles is deteriorating. In order to reduce the possibility of wind damage it is recommended the ridge tiles are lifted, cleaned off and then rebedded in new mortar.

There are a number of defective tiles which need replacing. These include individual missing, slipped and cracked tiles to the front and rear slopes.

Roof and chimney detail

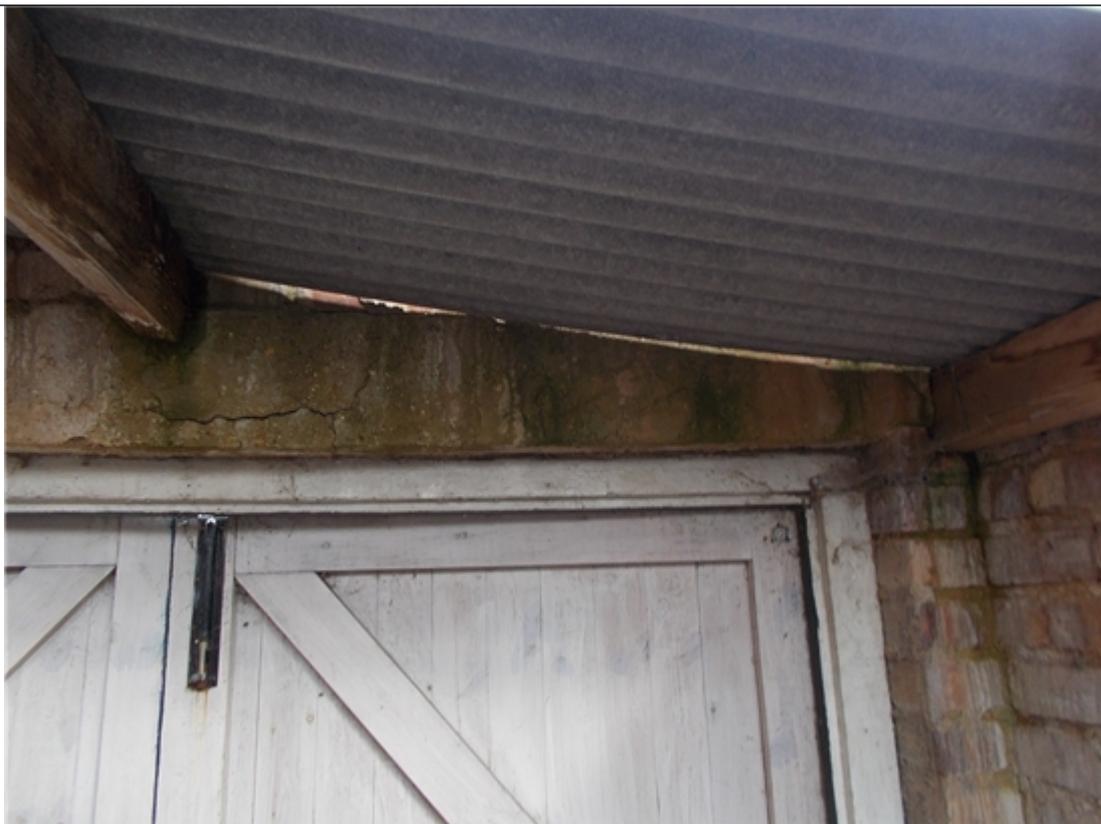
It is in a general state of deterioration. Stains internally indicate the roof is or has been leaking. Mortar between brickwork is weathered/powdery and needs repointing. The front and in particular rear doors are rotten. There is evidence that the lintel over the front door has started to fail as indicated by cracking internally and externally. It will probably have to be replaced etc. You should budget for renovation sooner rather than later.

Garage interior showing damp and cracking to lintel

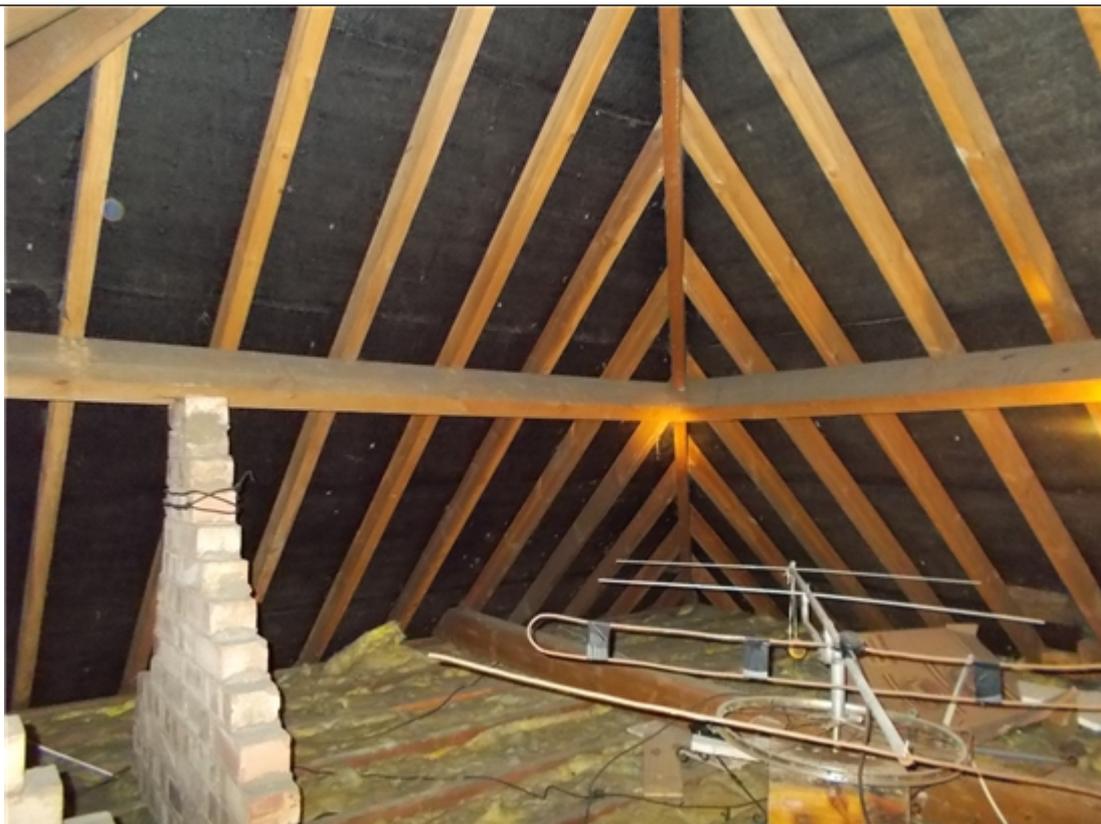
Roof space

The roof covering is supported by a traditional timber frame of down rafters and cross purlins. No evidence of significant defects is apparent.

There is a thin depth layer of fibre glass insulation only laid across ceilings. Details of energy improvements available can be found by inserting the postcode of the property and referring to [www.epcregister.com](http://www.epcregister.com).

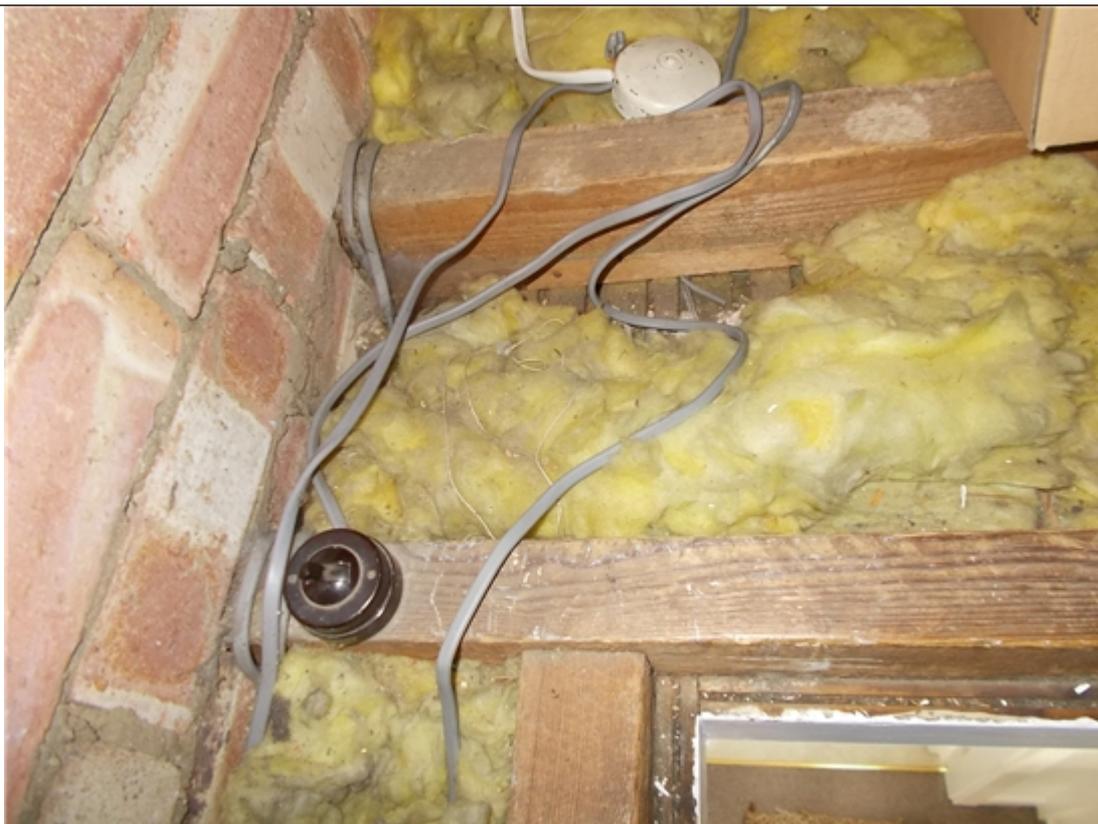
It is not possible to fully assess the condition of an electric installation on the basis of a visual inspection only. There are many factors relating to the adequacy of electrical installations which can only be identified by a circuit test. Our comments based on a visual inspection only are as follows. 3

Wiring in roof space

As such you should have the system tested now by a qualified electrician to ensure current wiring regulations including Part P of the Building Regulations are complied with. You should implement upgrading recommendations made in full.
