LEVEL 2

Your survey report

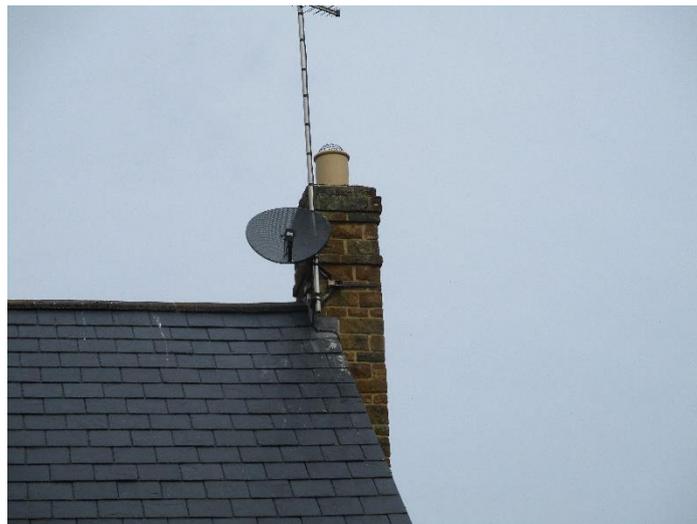
Chimney stack.

A TV aerial is attached to the stack. The fixing should be checked from time to time for signs of deterioration and to ensure it remains secure.

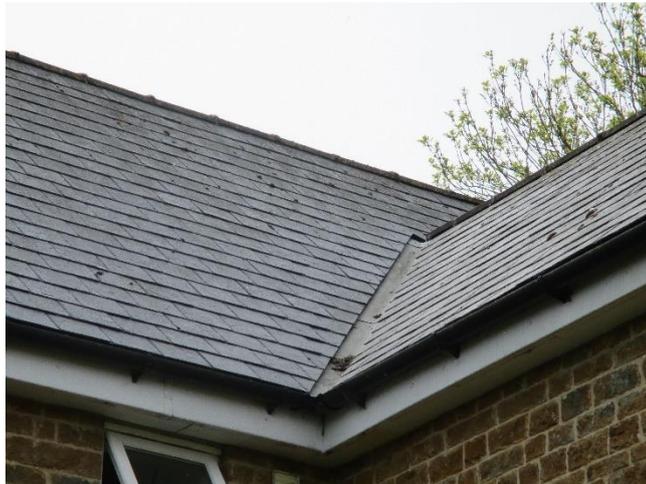
The property has two fibreglass lined valley gutters to the rear elevation. These are at the junction of the roof slopes. The nature and condition of the lining appears to be satisfactory although they are currently blocked with vegetation. Leaves will need to be cleared regularly. Periodic inspections and clearing are recommended.

Unblock valley gutter.

Moss growth was noted in places. It is difficult to eradicate moss fully and you should be aware that it does tend to fall away and block valleys, gutters and downpipes, so increasing the maintenance requirements to these areas. It should be cleared with a soft brush periodically to allow better rainwater drainage.

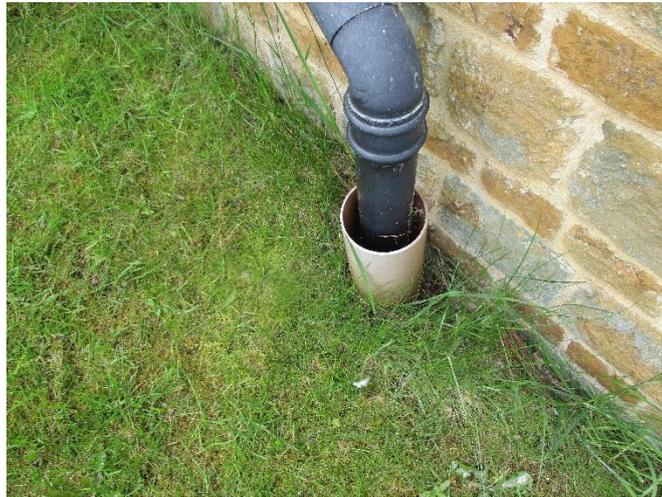
The down pipe to the rear right-hand corner (kitchen) is connected to a sealed gulley. However, the gulley does not have a suitable cover installed. This may allow blockage through vegetation and debris. A suitable cover should be fitted.

Install gully cover.

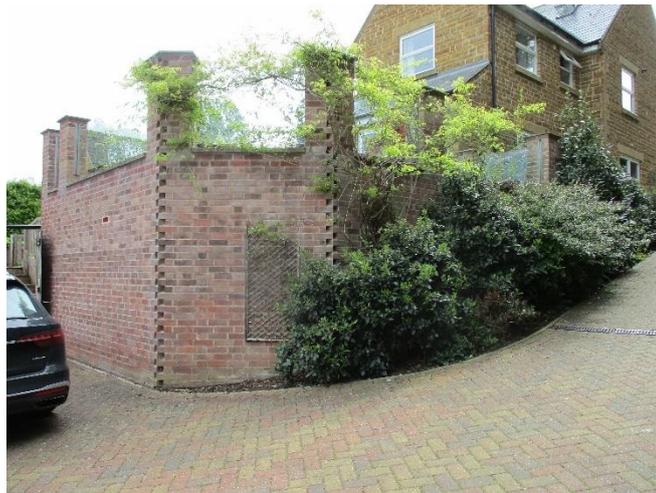
However, the ground levels to the left-hand side are deemed to be too high in relation to the studio located beneath the terrace. It is understood from the vendor that the walls were suitably damp proofed (tanked). However, this cannot be ascertained without invasive inspection behind the plaster board lining. No evidence of dampness was noted.

High ground levels around the studio.

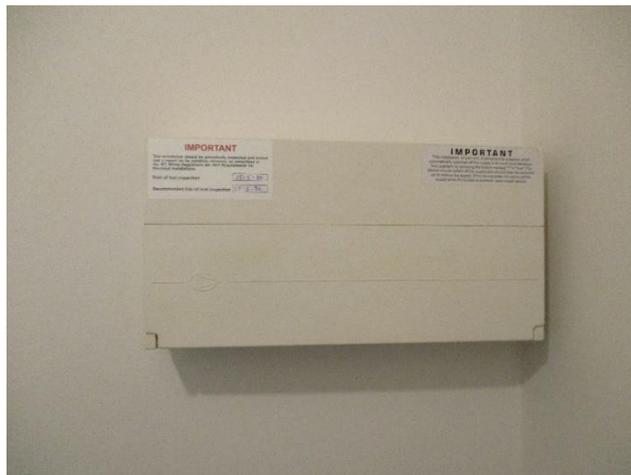
Electrical consumer unit.

We have not carried out tests on the system. Whilst there are no obvious defects based on our limited visual inspection it is not known if the installation is covered by a current inspection and testing certificate. As such you should have it tested now by a qualified electrician to ensure current wiring regulations including Part P of the Building Regulations are complied with. You should implement any upgrading recommendations made in full.

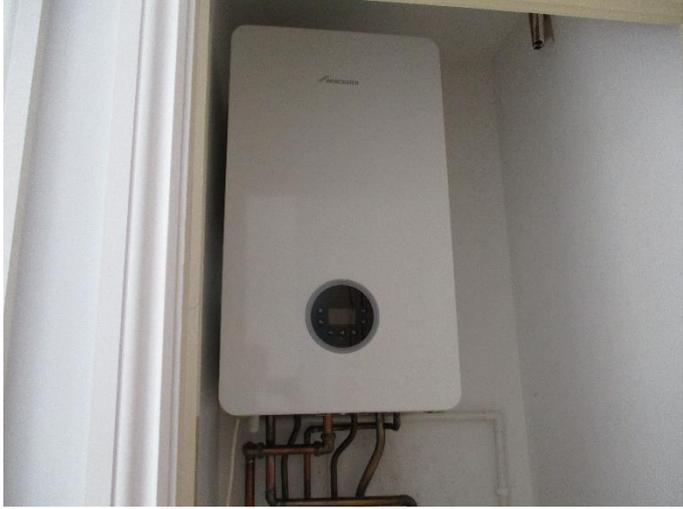
Boiler.

There are no visible signs of any significant defects in the system and there is no particular reason to think it is not effective. Annual servicing is recommended.

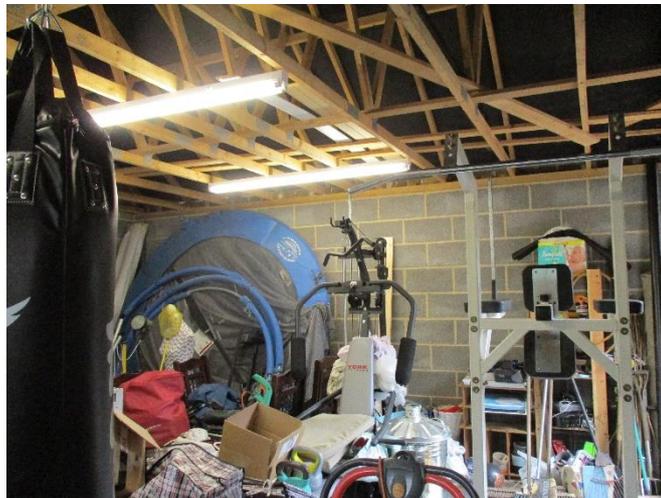
There is a double garage, and although containing stored items, it was noted to be in a serviceable condition for its purpose.

It was noted that a slate has cracked to the front roof slope and this will require replacement.

Garage filled with stored items.
