# Your survey report

Surveyor's RICS number

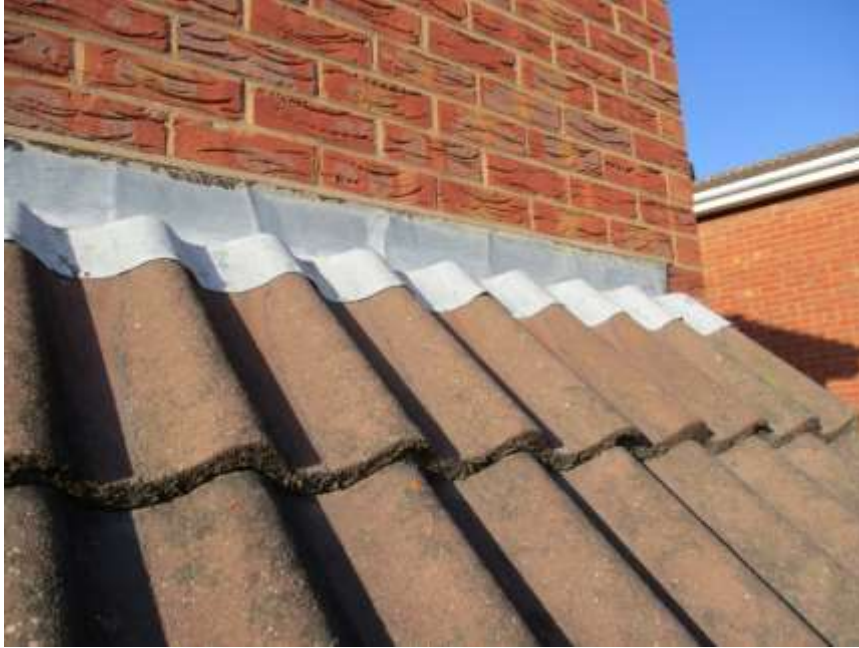
The porch and single storey roof section over the bay to the front is of a pitched and hipped nature with a covering of interlocking concrete tiles. There are lead flashings where it abuts the front wall and lead lined valleys. The covering, flashings and valley are in a serviceable condition.

**Lead flashings satisfactory**

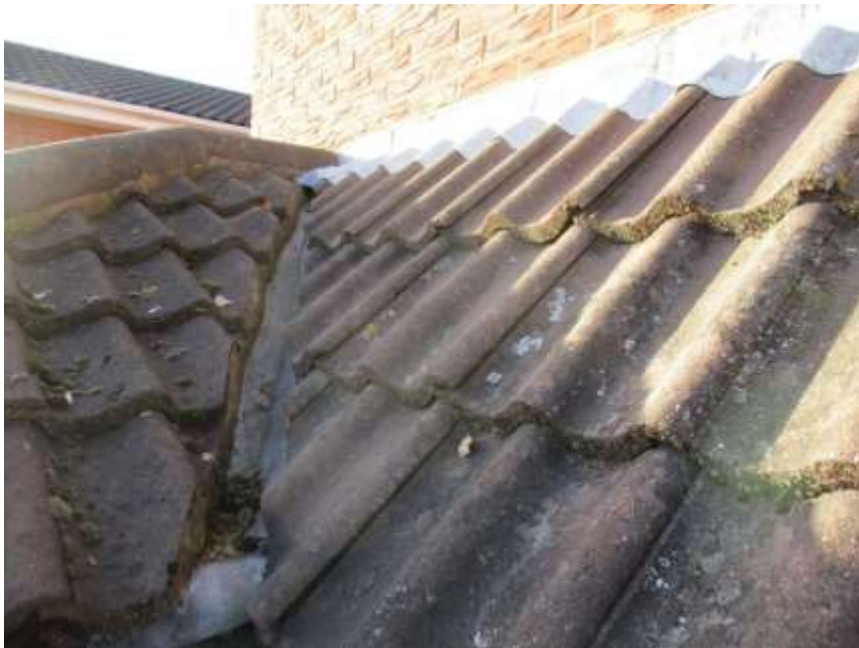
**Valley to porch clear**

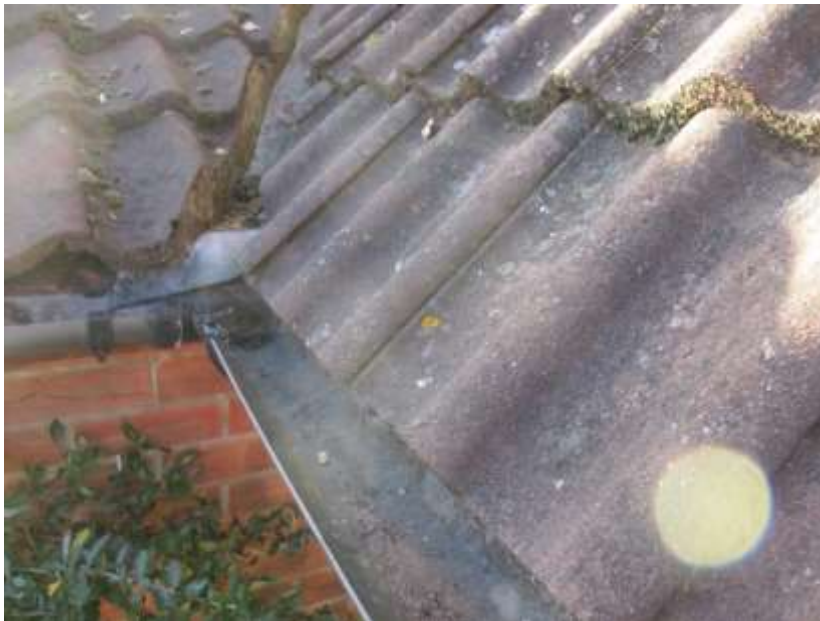
The rainwater pipes and gutters are made of PVC. Although it was not raining fittings appear to be in serviceable condition. Their exact condition can only be established during rainfall.

**Gutters clear**

Keeping the fittings clear of blockage, properly aligned and with sealed joints is important to avoid problems such as damp and timber decay which may be caused by rainwater penetration. Ideally fittings should be checked annually, preferably after Autumn leaf fall.

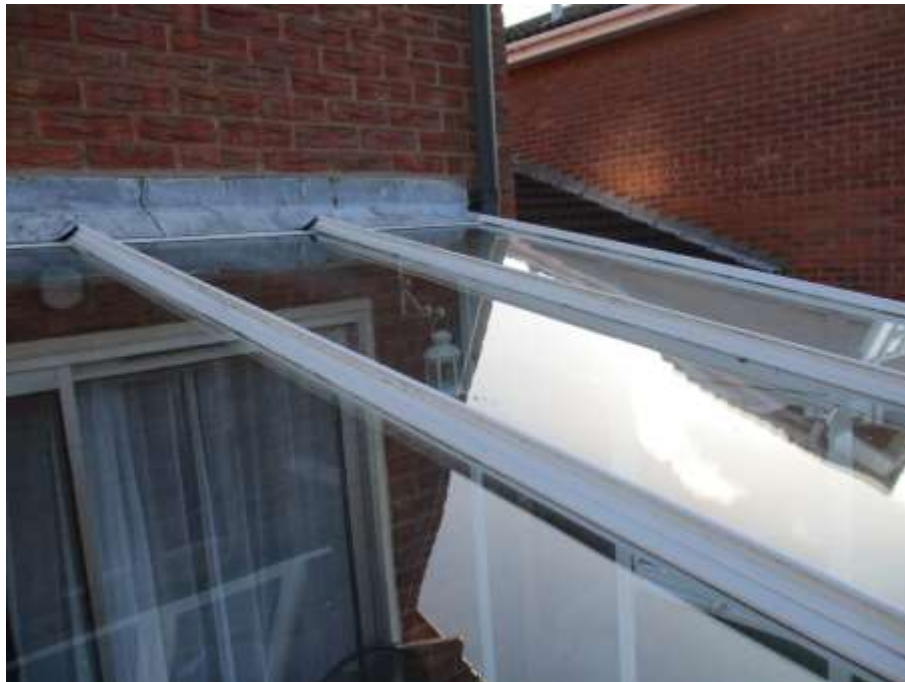
**Lead flashings to conservatory roof**

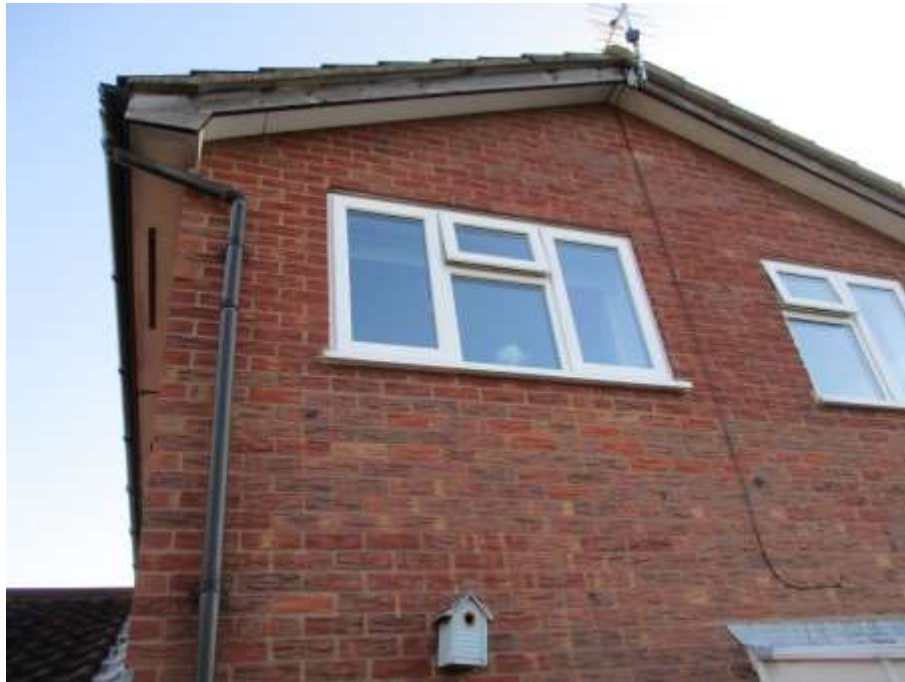
**Facia boards require decoration**

Redecoration is recommended including thorough preparation, removal of all loose and flaking paint, filling of cracks, and priming bare surfaces prior to the application of undercoat and gloss coats.

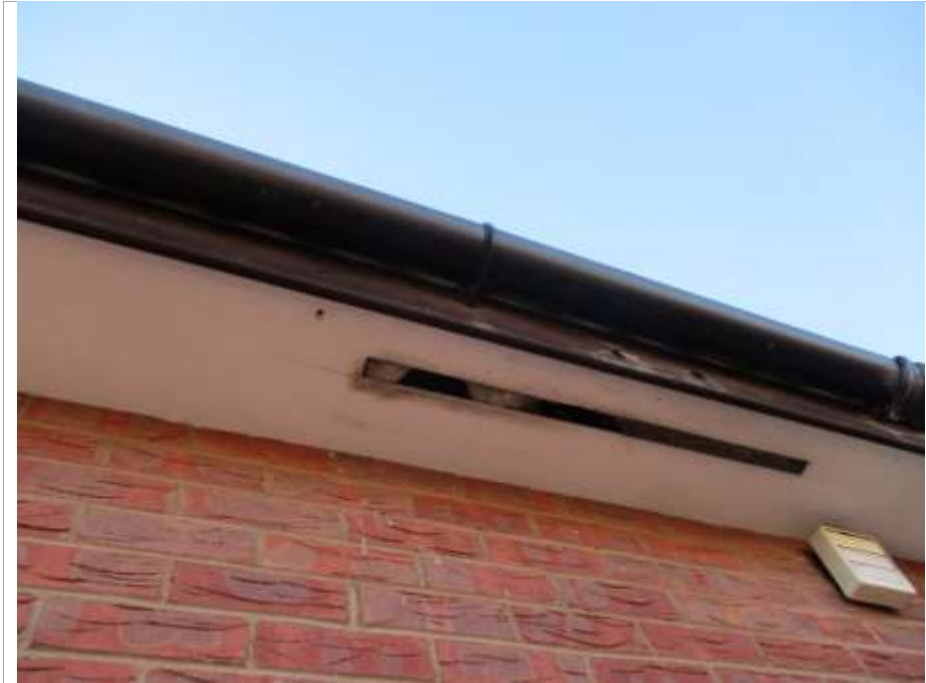
The soffit boards to the property consist of cement asbestos boarding. This was common during the period of build. The soffits are in a serviceable condition. You should follow the advice as below.

**Ventilated cement asbestos soffit boards**  
**Condition Rating 2**

We have made reference to the presence of asbestos. Asbestos is contained in thousands of building products including Artex, roofing felt and vinyl floor tiles manufactured until the 1980s. It was used in the UK until 1999 in the construction industry prior to this time. Any work on the material (for example drilling, sawing or removal) can pose a health hazard and a minority of potential purchasers may be put off by its presence. You should therefore take the advice of a licensed asbestos contractor before undertaking work on asbestos. If it is to be removed it should

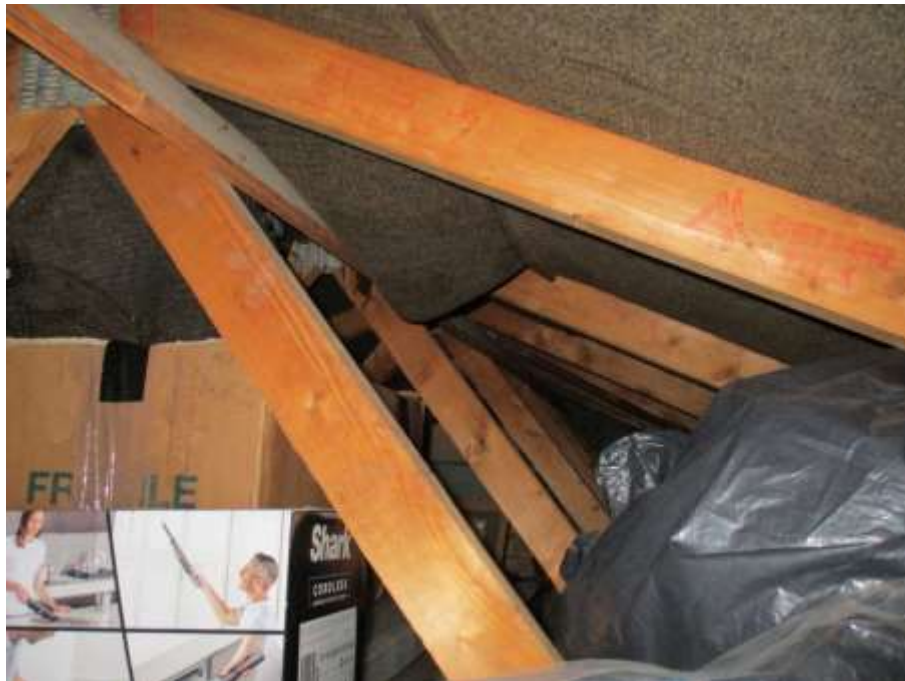
The roof covering is supported by a timber frame of trussed down rafters which are cross braced. No evidence of significant defects is apparent.

**Roof structure**

No cutting out of these prefabricated timbers should be undertaken without specialist advice.

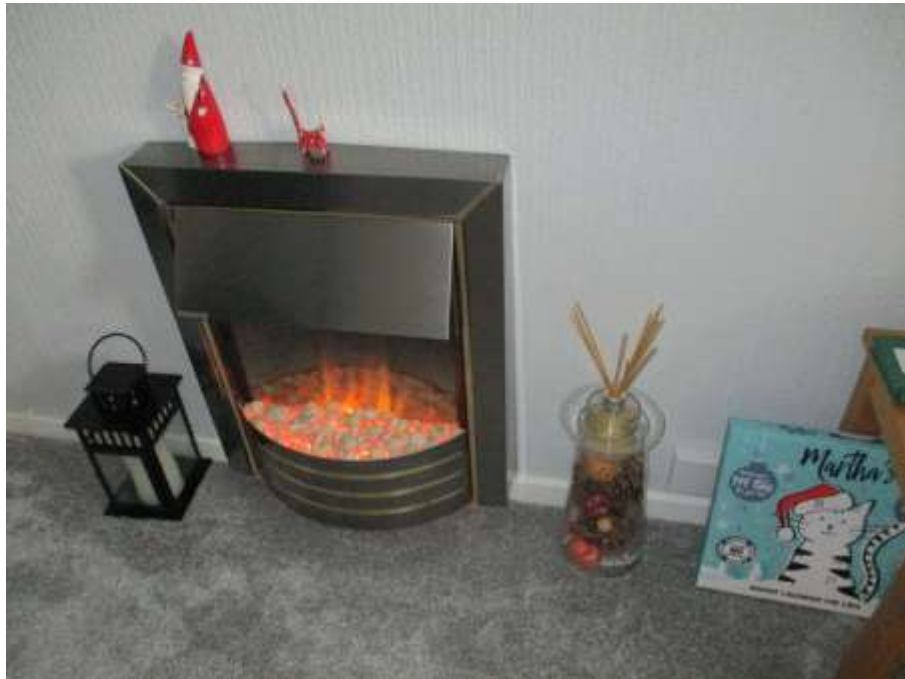
**Electric fire living room**

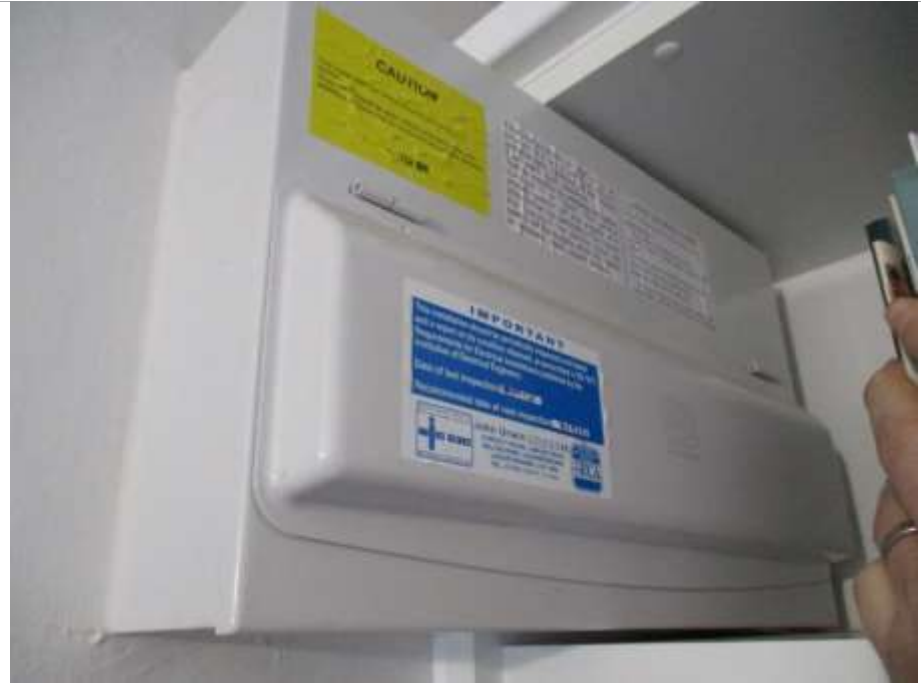
**RCD**

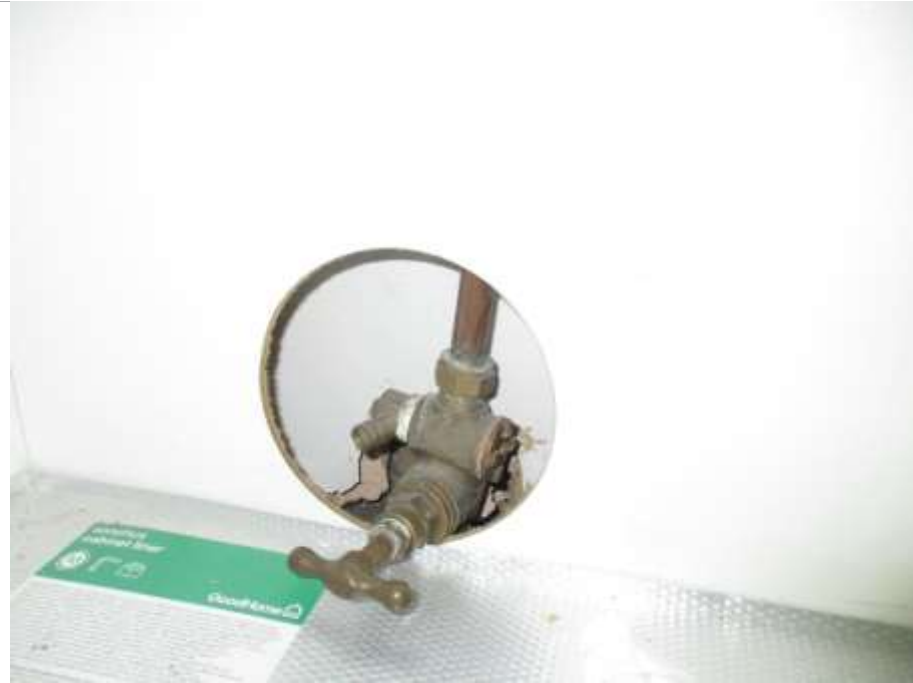
**Main stop tap under kitchen sink**

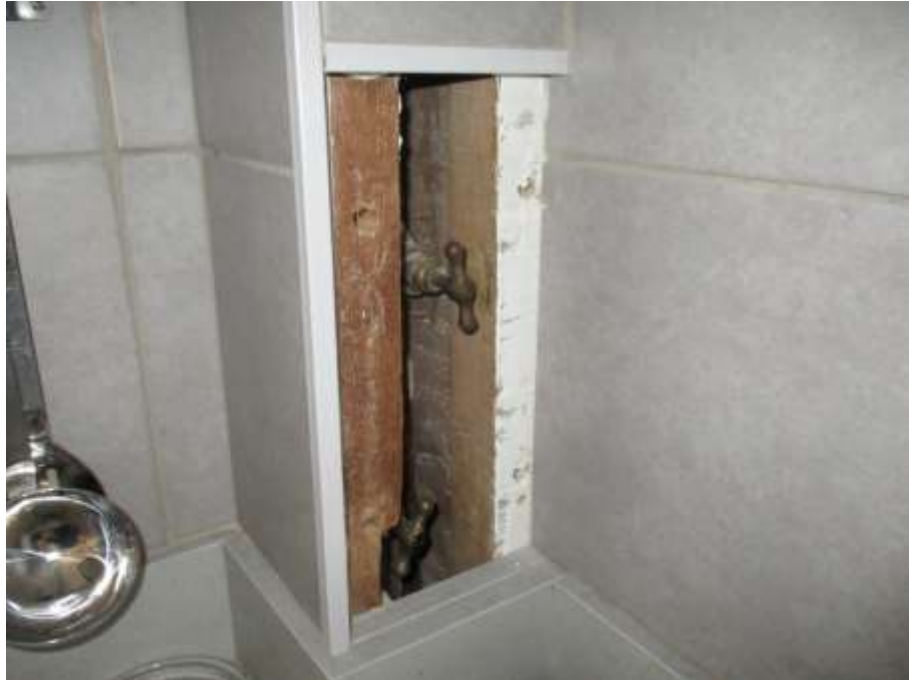
**Additional stop taps in kitchen behind cover**

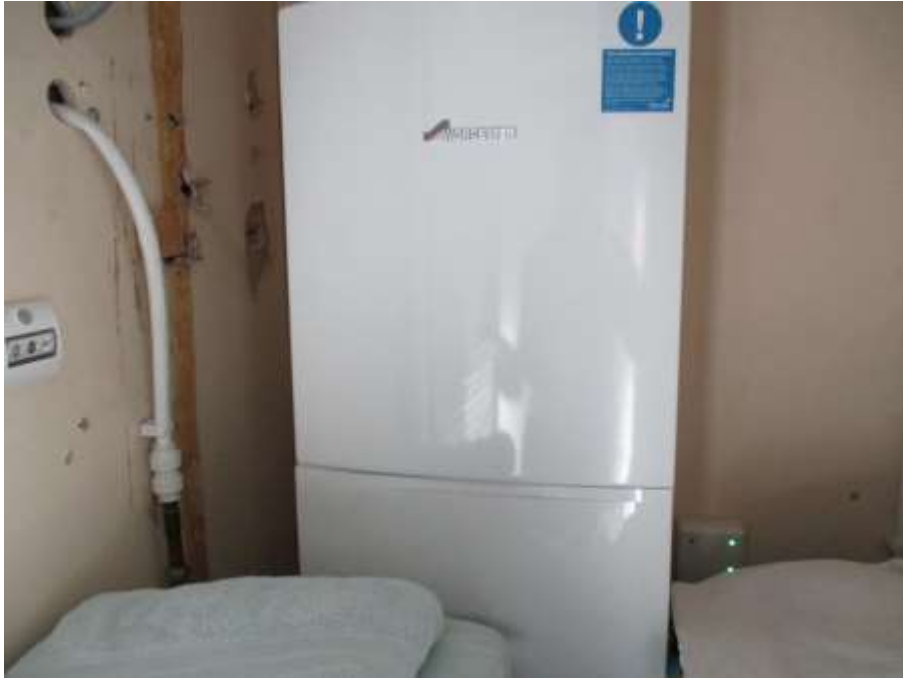
It is connected to the hot water radiator. The system was on during our inspection. There are no visible signs of any defects in the system. Annual servicing is recommended.

**Gas fired boiler**

You should fit a carbon monoxide detector close to the central heating boiler and other heating appliances, gas hobs etc. Check regularly they work properly.

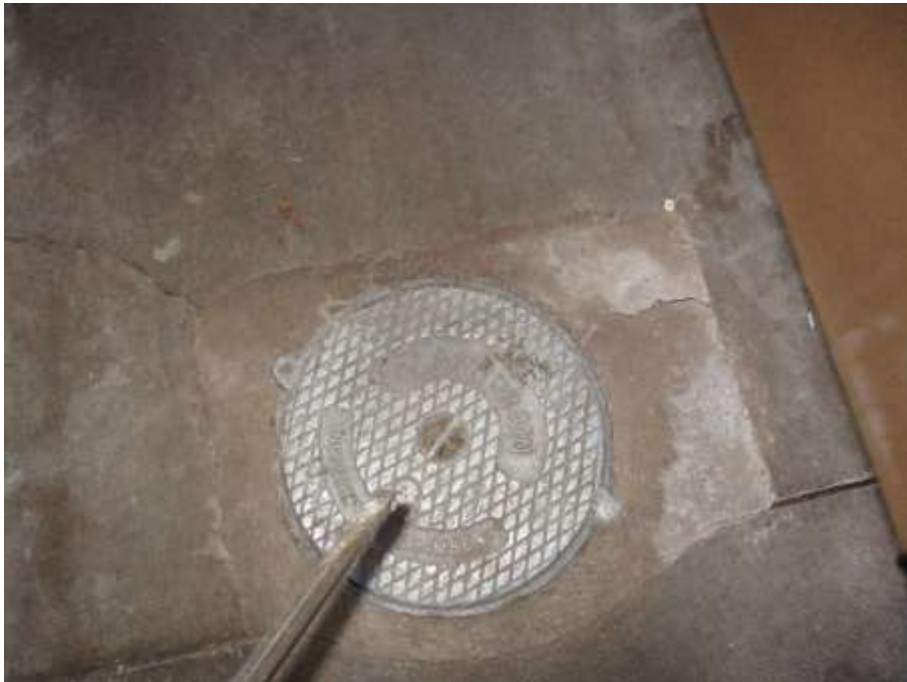
**Screw sealed down to rodding point**

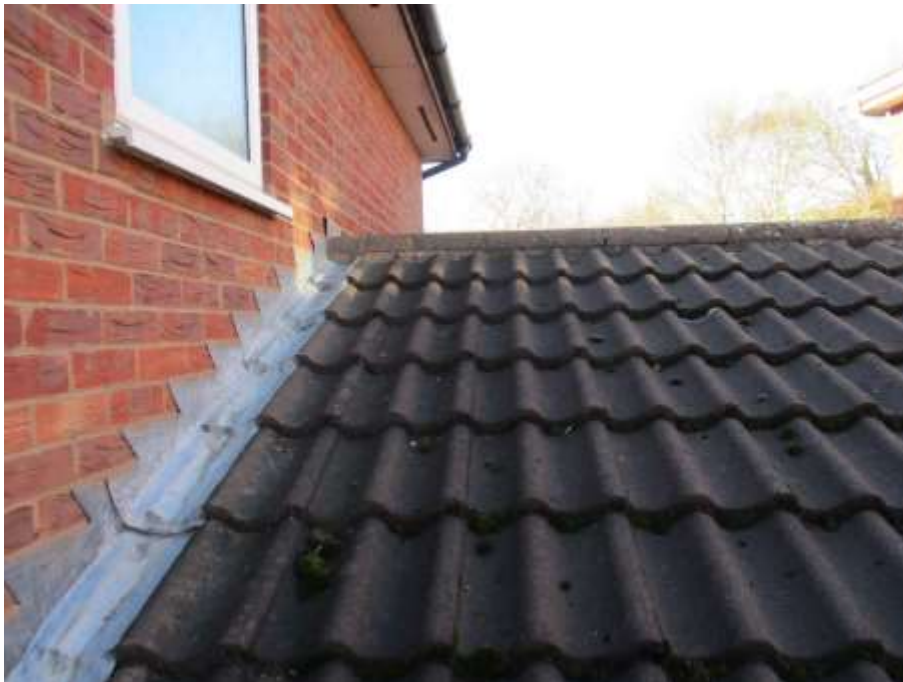
There is a single garage of brick construction which has a pitched timber framed roof with a covering of interlocking concrete tiles and felt lining beneath. There are lead flashings where the roof abuts the house wall. The covering, flashings and ridge tiles are all in a serviceable condition.

Lead flashings between garage and main wall

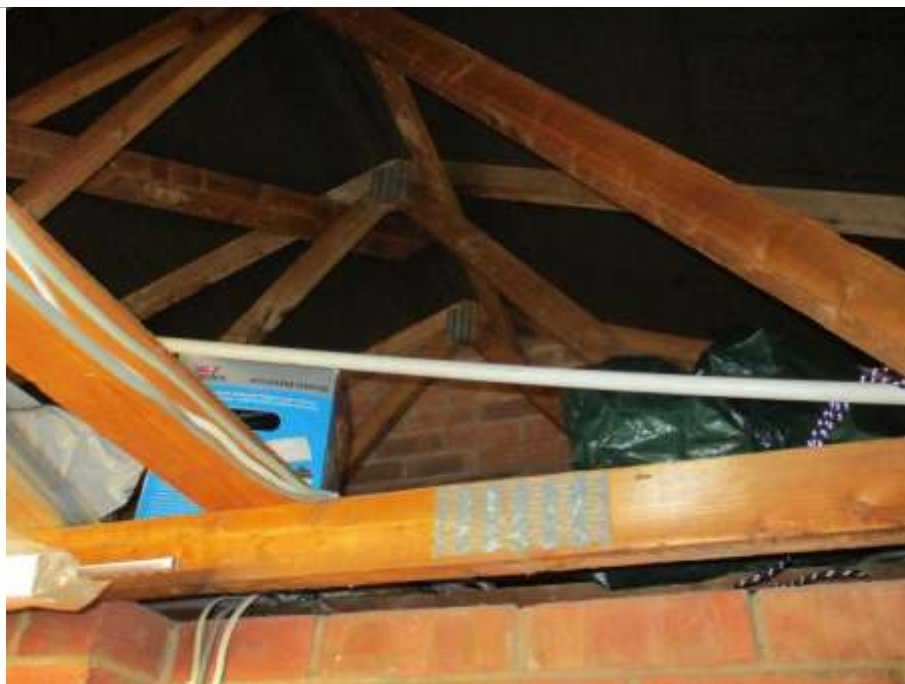
**Garage roof structure**
