SHIRE SURVEYORS
CHARTERED SURVEYORS

LEVEL 1

Your survey report

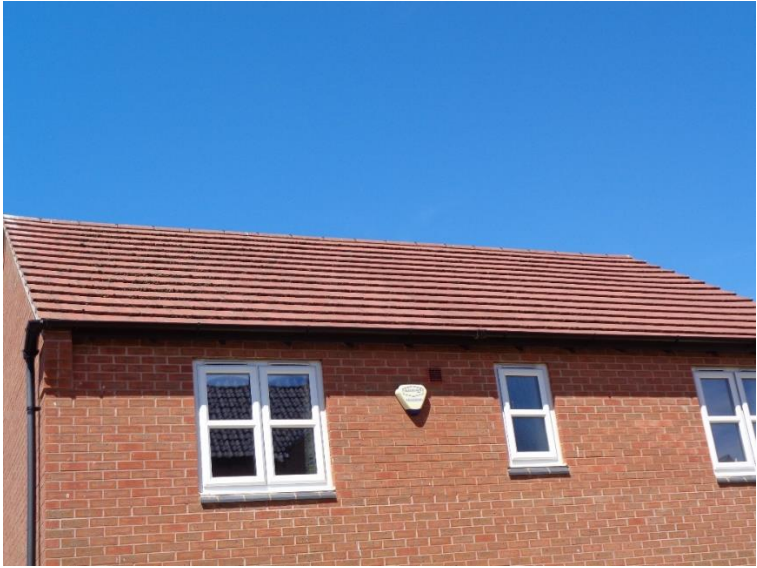
The roof is a pitched (sloping) timber-framed structure, covered with concrete tiles which have been laid over a breathable lining. The lining provides a secondary defence against rainwater penetration. The covering is in serviceable condition. 1

The roof incorporates a dry ridge system. This is in a satisfactory condition.

The verge mortar to the roof is in a satisfactory condition.

Front roof slope
Condition Rating 1.

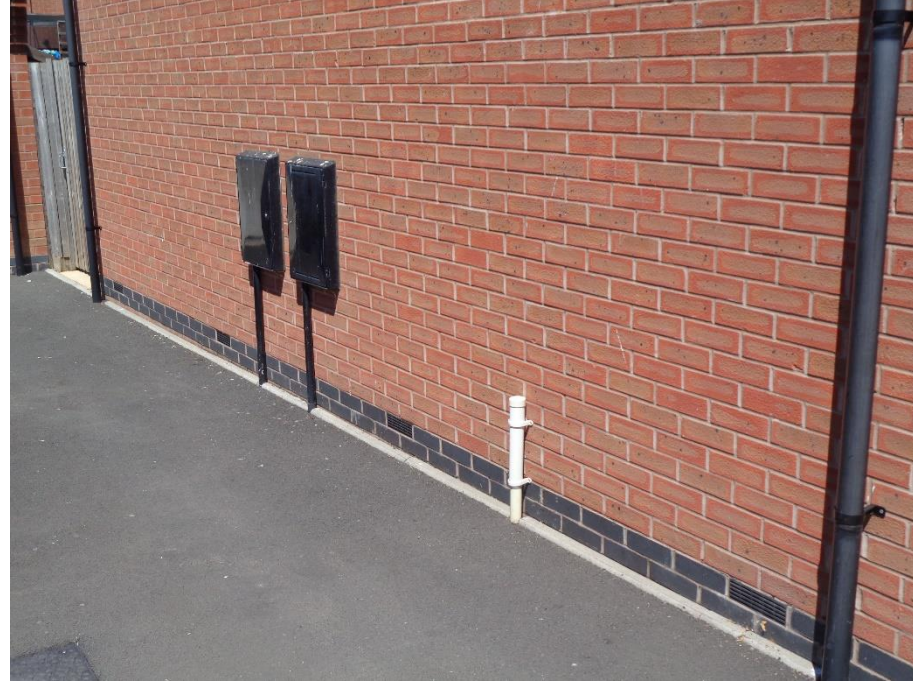
Ventilation to suspended concrete flooring
Condition Rating 1.

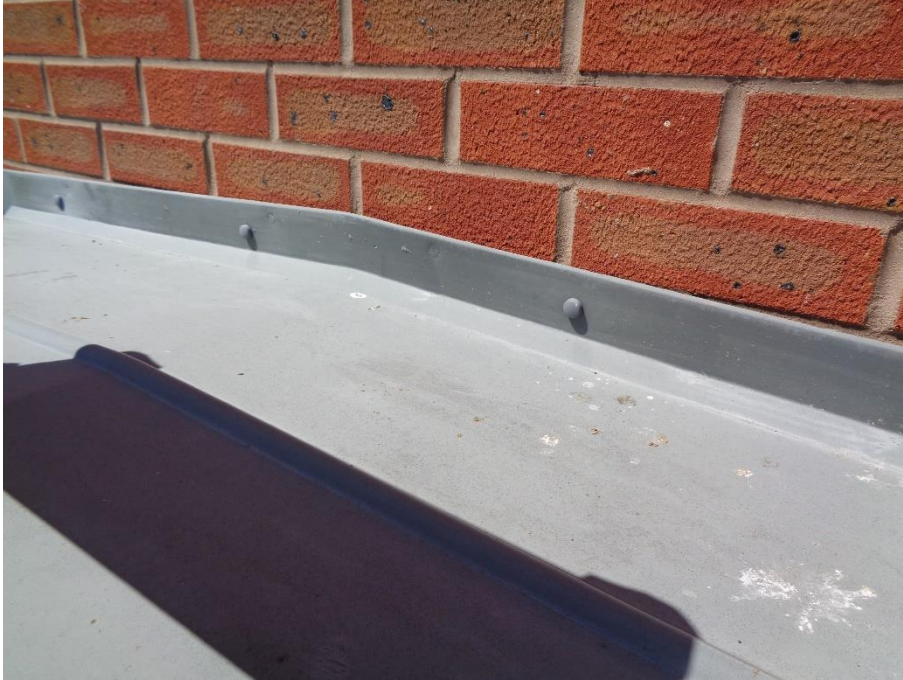
There is a PVC canopy to the front with a covering of fibre glass. This is in a satisfactory condition.

Fibreglass covering to front canopy

Condition Rating 1.

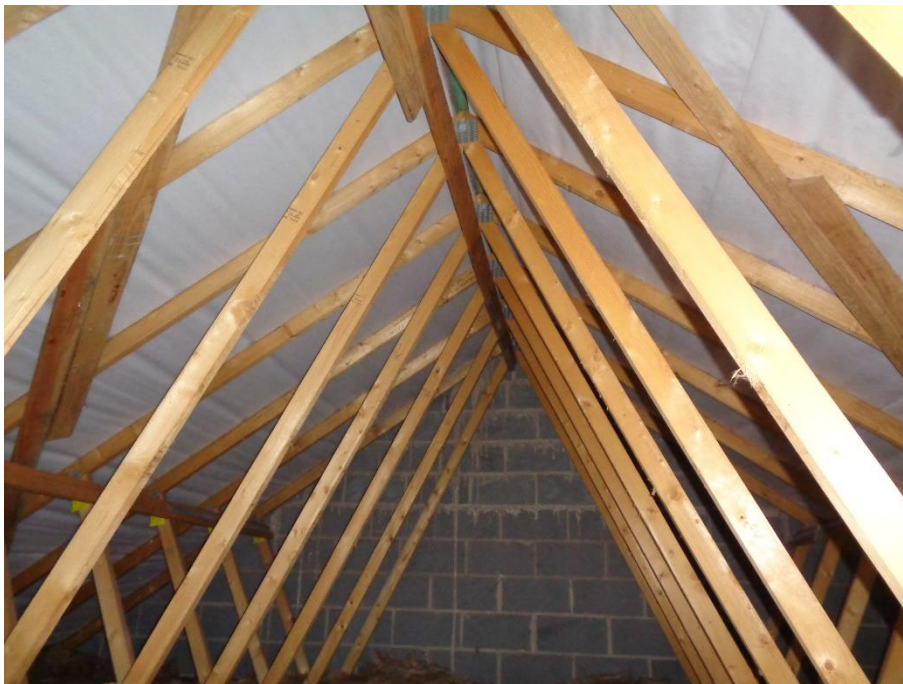
The roof covering is supported by a timber frame of trussed down rafters which are cross braced. No evidence of significant defects is apparent.

Roof structure

Condition Rating 1.

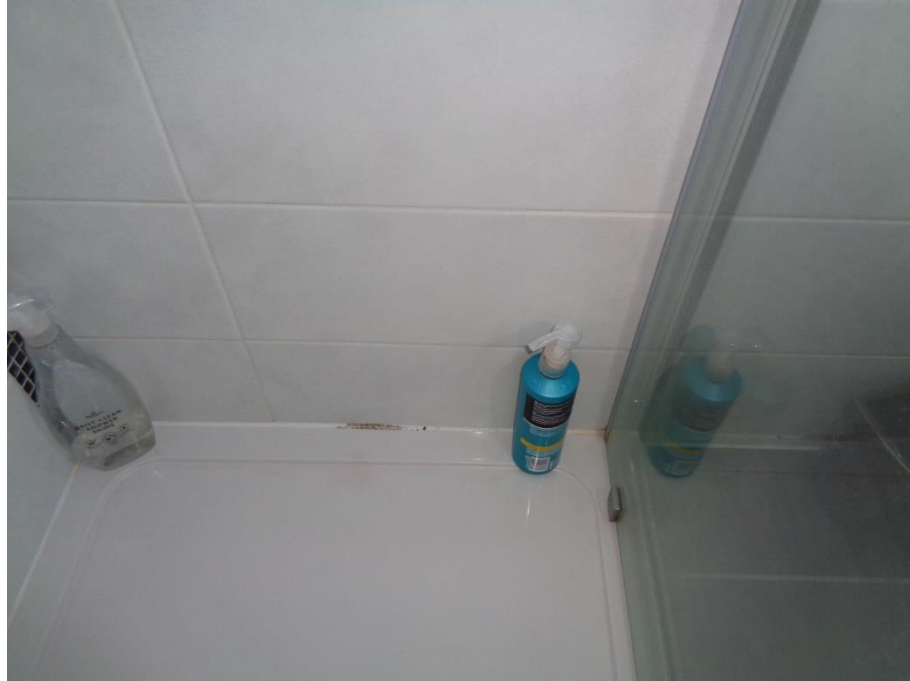
Off bedroom number one there is a fully tiled ensuite with extractor fan and three piece suite consisting of mixer shower and cubicle, WC and wash hand basin. The fittings are serviceable but mould was noted to the sealant and this should be replaced.

Mould to sealant of ensuite shower

Condition Rating 2.

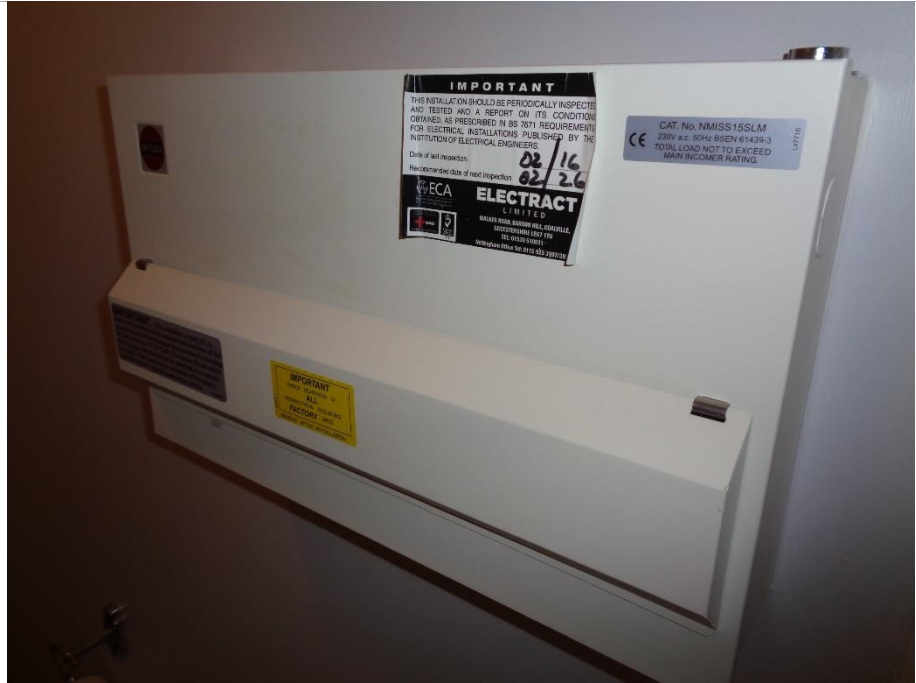
There is a mains electrical supply. The meter is located to the left-hand wall and the residual current device (RCD) consumer unit is located in the cloakroom. The sticker states that this was installed in 2016 and the next test is due in 2026. Regulations have changed and testing is now recommended every five years.

RCD in cloakroom
Condition Rating 3.

We have not carried out tests on the system. Whilst there are no obvious defects based on our limited visual inspection it is not known if the installation is covered by a current inspection and testing certificate. As such you should have it tested now by a qualified electrician to ensure current wiring regulations including Part P of the Building Regulations are complied with. You should implement any upgrading recommendations made in full.

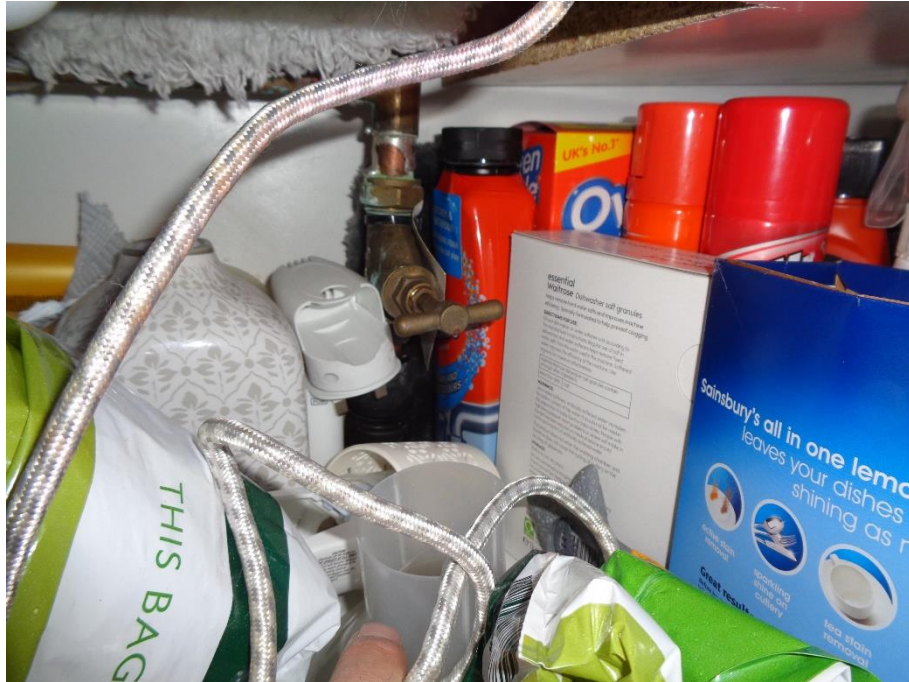
Mains water connects to copper plumbing where visible. There are no obvious indications of urgent or significant defects based on our visual inspection. The stop tap to the rising main is under kitchen sink. There are no cold-water tanks visible which is usual with this boiler set up.

Stop tap under kitchen sink

Condition Rating 1.

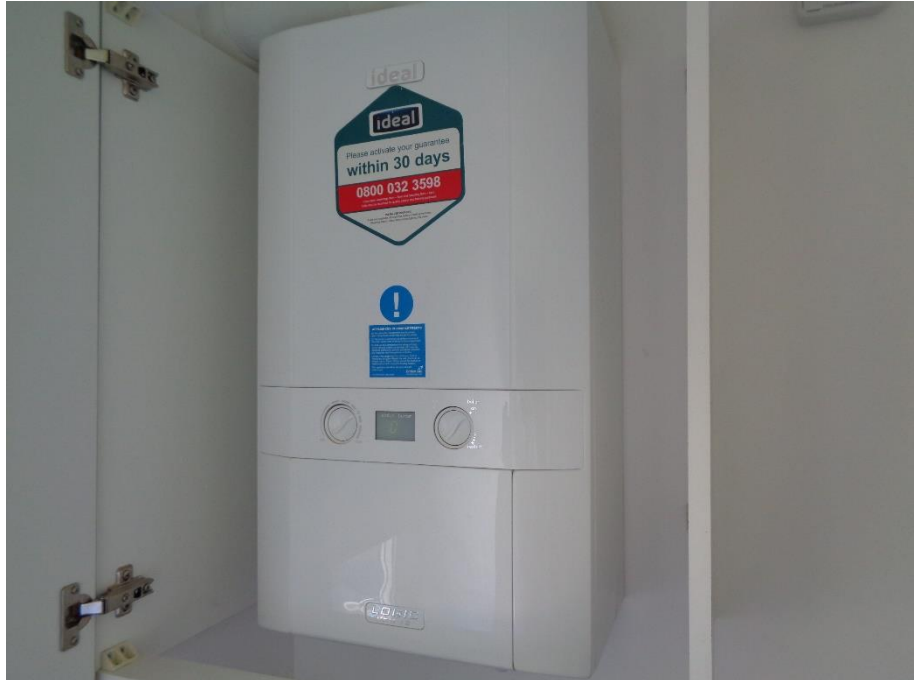
There are no visible signs of any significant defects in the system, and there is no particular reason to think it is not effective.

Gas fired boiler

Condition Rating 3.

However, the service record has not been seen and as such you should have the system serviced by an engineer on the gas safe register (www.gassaferegister.co.uk) before a legal commitment to purchase. Annual servicing is recommended. Your Legal Advisers should enquire about the boiler service records. This advice can be lifted if recent satisfactory service/test documents are available.

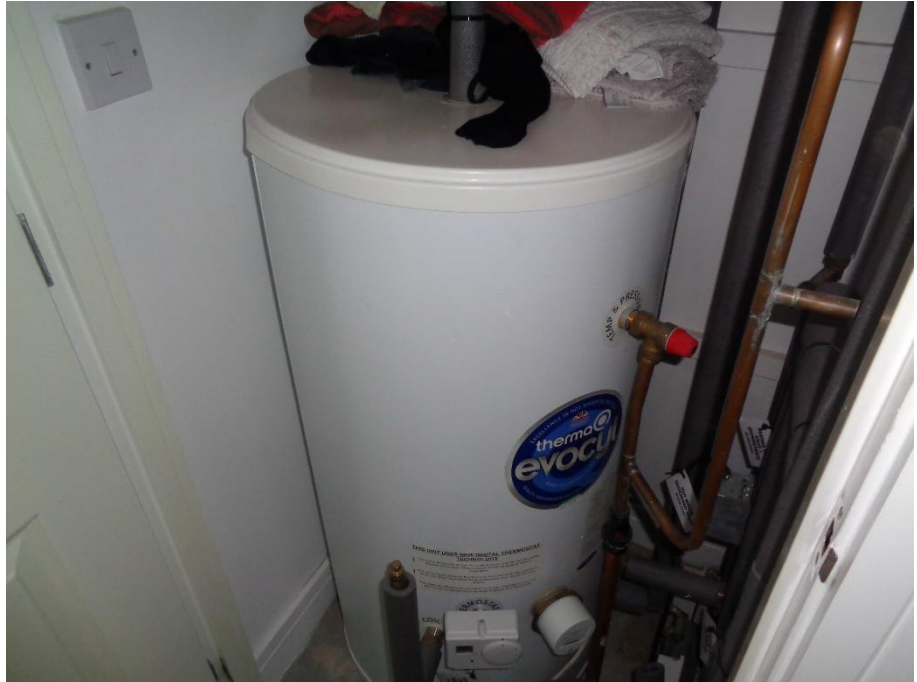
There are no visible signs of any significant defects in the system, and there is no particular reason to think it is not effective.

Pressurised hot water cylinder

Condition Rating 3.

However, as with Section G4, the service record has not been seen and as such you should have the system serviced by a competent engineer before a legal commitment to purchase. Annual servicing is recommended. Your Legal Advisers should enquire about the service records. This advice can be lifted if recent satisfactory service/test documents are available.

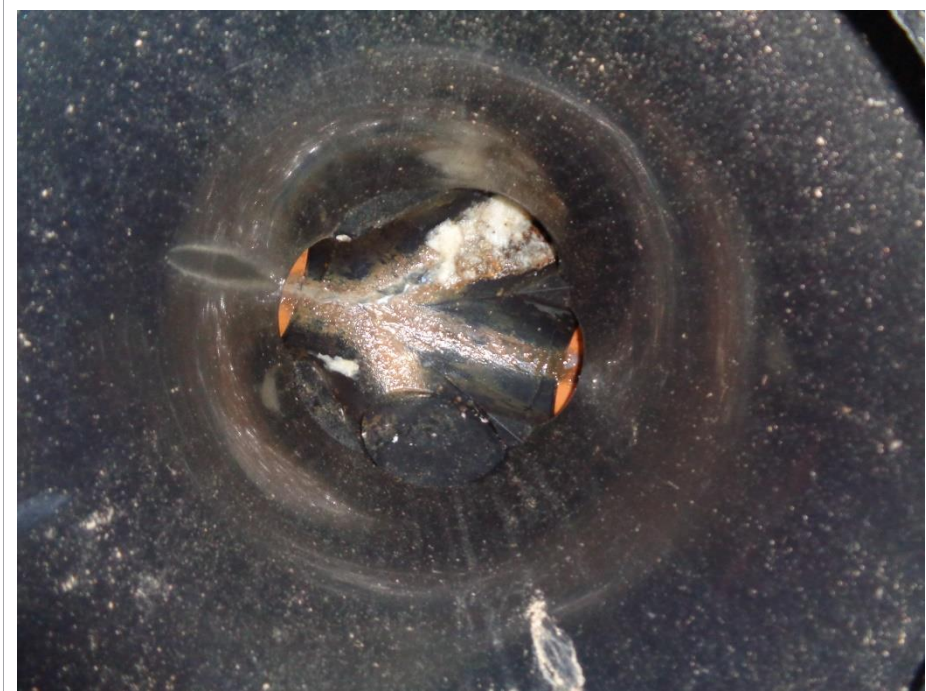
Waste debris was found within both chambers to the right-hand side and these require clearing. The chambers should be thoroughly cleaned with a jet washer and flushed through to ensure they flow freely.

Rear drain to right needs flushing through

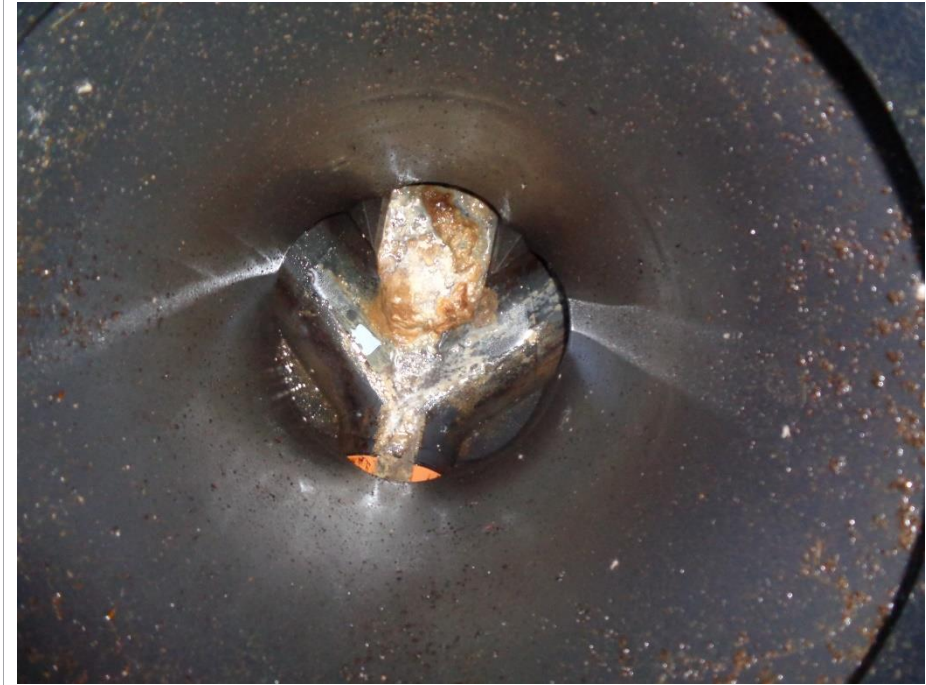
Front drain to right needs flushing through

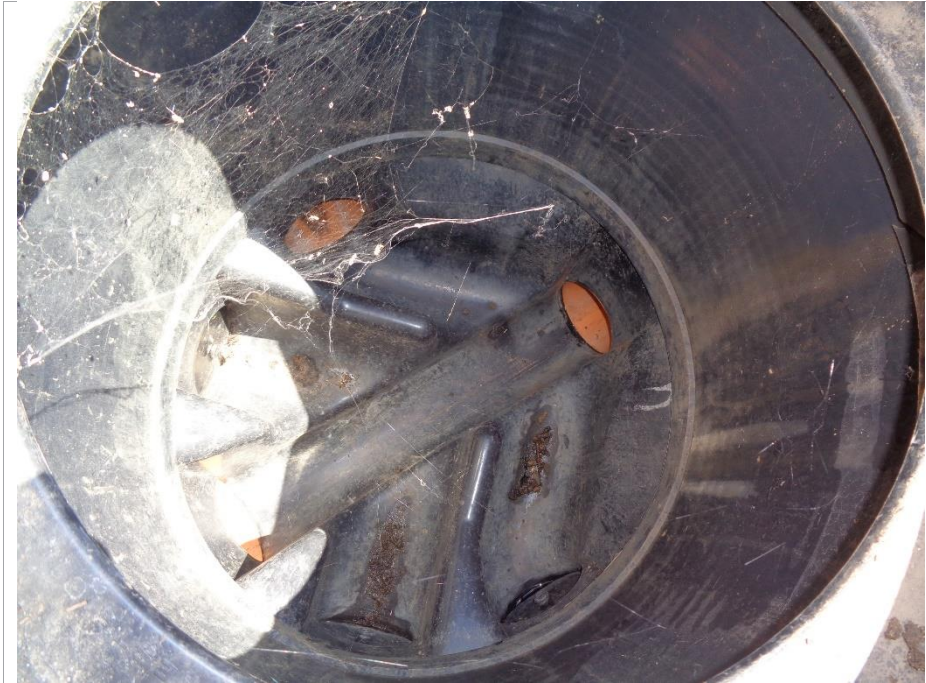
It is assumed that the foul and rainwater drains connect to the main sewer. The large inspection cover to the driveway was raised. The drain run at this point was free of obstruction and there are no above ground signs of obvious defects. In the absence of a full inspection by a drainage specialist you must accept the risk of hidden defects existing.

Drain to driveway running clear

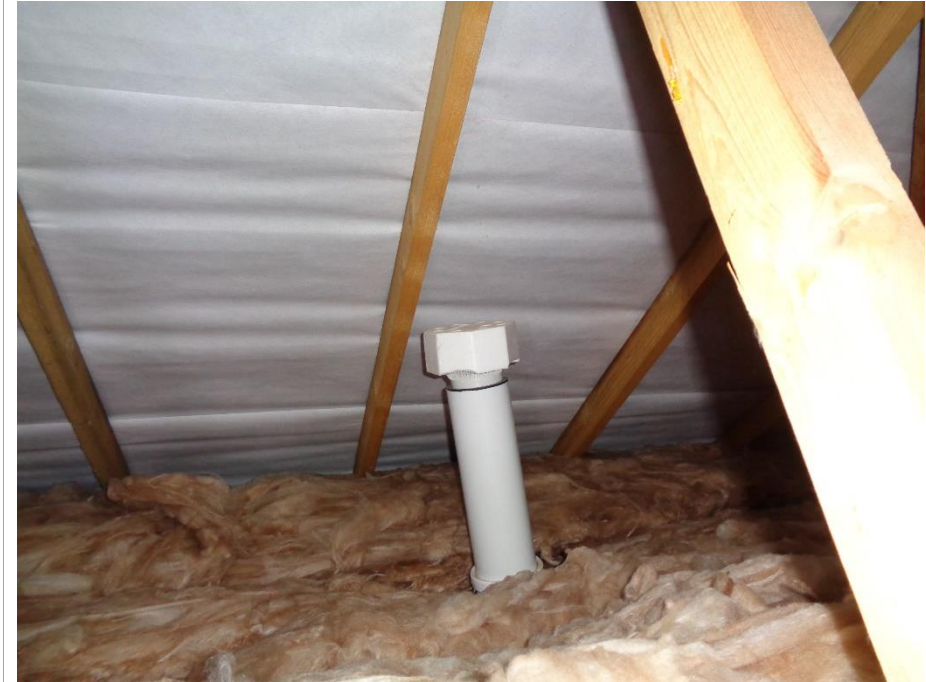
**PVC soil vent with air admittance valve in roof space
Condition Rating 2.**

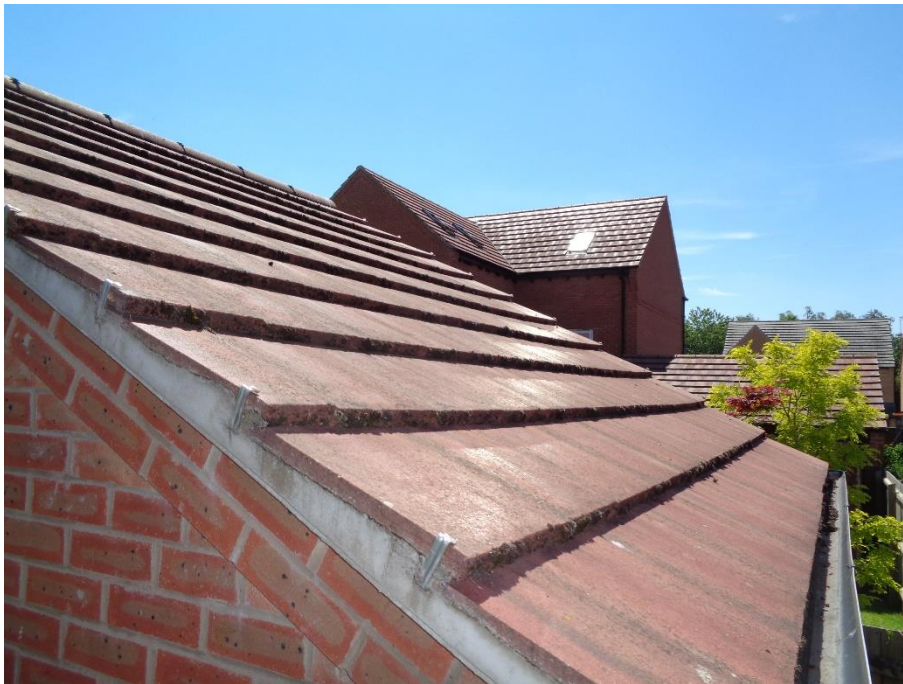
No key was provided for the garage so this could only be inspected externally. The garage is detached and of brick construction with a pitched concrete tiled roof. The garage has a manual up and over door.

From external inspection the garage is in a serviceable condition.

Rear roof slope of garage

Condition Rating *
