SHIRE SURVEYORS
CHARTERED SURVEYORS

LEVEL 2

Your survey and valuation report

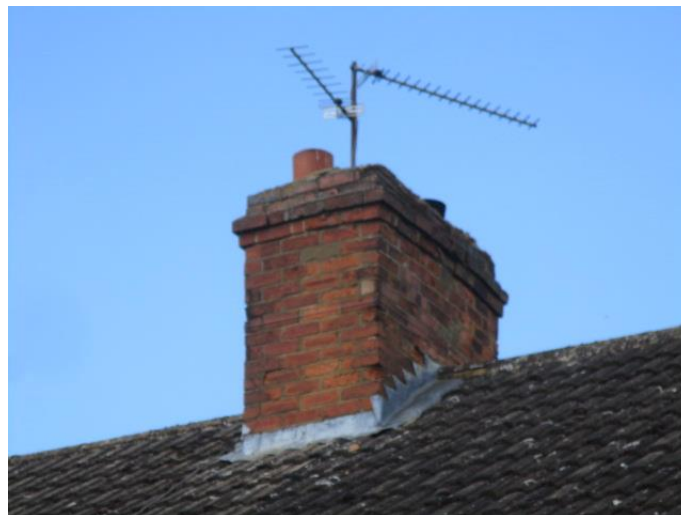
The lead flashings around the base are loose and upturned and require redressing to the brickwork.

Spalling occurs when bricks become wet. If freezing conditions occur before the brickwork dries out, the trapped moisture expands and forces off the hard face of the bricks exposing the softer inner core. The spalled bricks should either be repointed with mortar or alternatively be cut out and replaced with new bricks. This is now occurring to the chimney stack.

Repairs to chimney.

The owner of the neighbouring property may have a number of legal rights over this shared chimney. You should check with them before starting work.

To repair the chimney safely and avoid damaging the roof covering, contractors may have to use appropriate access equipment such as scaffolding. This will add to the cost.

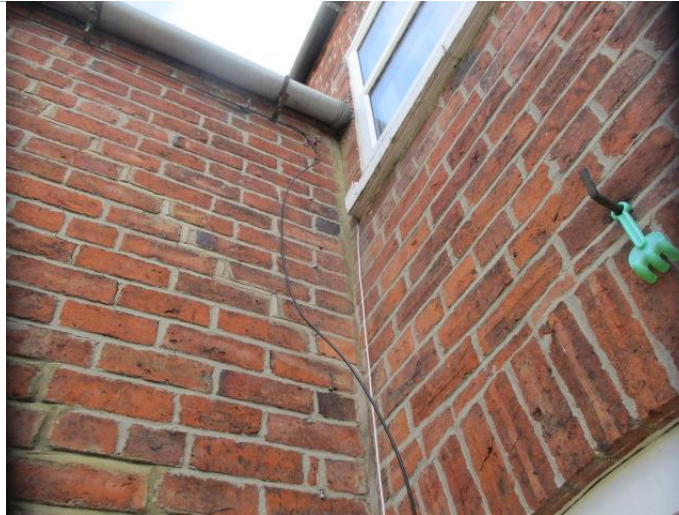
Structural movement is currently ongoing to the rear return elevation. Cracking was noted to both side elevation walls of the kitchen. A mortar joint in the corner above the kitchen door appears to be getting wider towards the top. This has been repointed in the past and cracking has occurred once again.

Structural cracking to rear return.

This indicates that the rear return is moving away from the main property. The mains drains run across the rear path adjacent to the rear wall of the kitchen. The drains are currently blocked (please see Section F6) and could be potentially leaking. This would erode sub soil and cause the subsidence to occur.

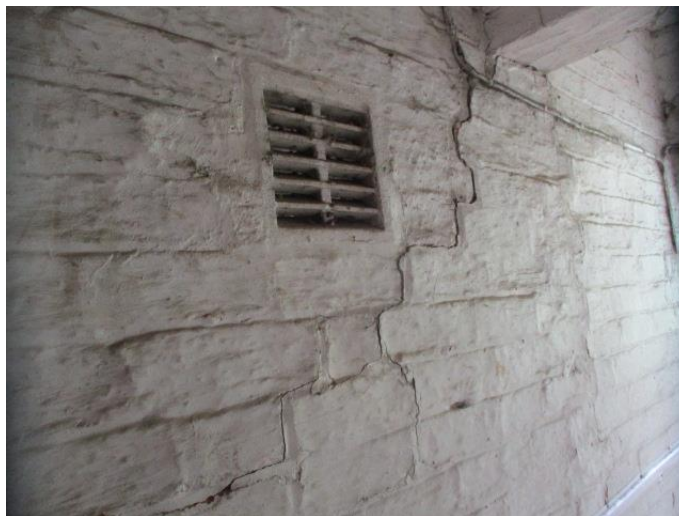
Structural cracking to passageway.

In a property of this age, it is probable the foundations will be fairly shallow and may therefore be at an increased risk of sub soil movement.

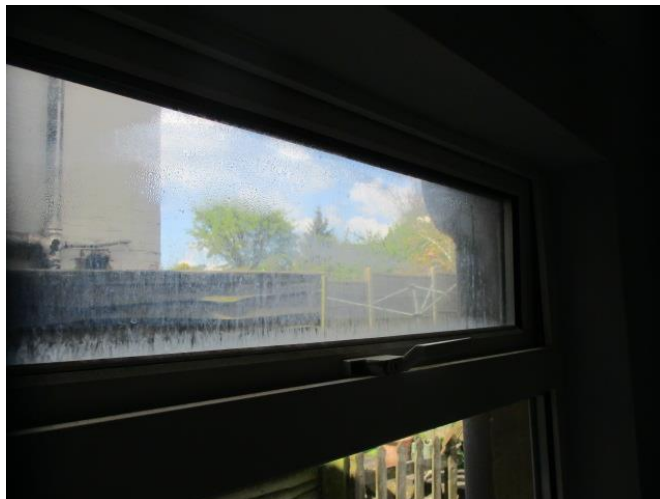
A number of sealed units have failed resulting in condensation and misting over. They should be replaced, eg the kitchen. This can often be done without having to change the frame.

Failed window unit.

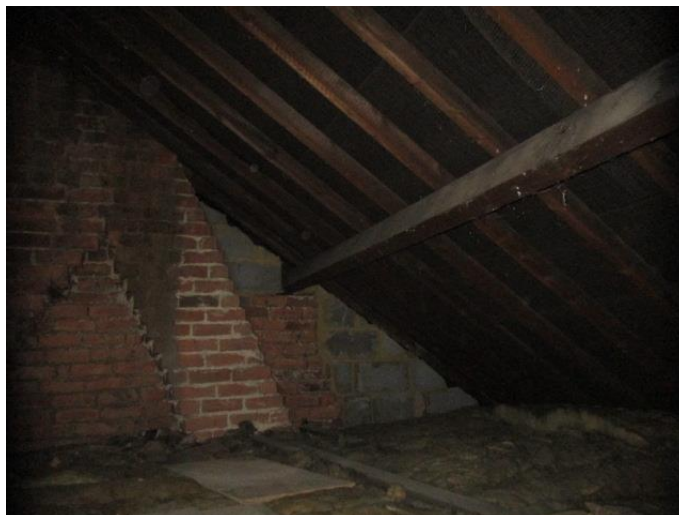
The roof covering is supported by a timber frame of trussed down rafters which are cross braced. No evidence of significant defects is apparent. The roof would originally have been covered with slate. The covering has been replaced with heavier concrete tiles. Ideally the roof structure should have been strengthened to take the additional weight. This has not been undertaken. However, no distortion to the roof frame was noted.

Roof structure.

There is no proper provision for ventilation of the roof space. This means that there is a risk that condensation could gather on the underside of the roof lining. This in turn could damage timbers and ceilings below. Whilst there is no evidence of this problem to date, ventilation should ideally be provided in the form of ventilation grilles to eaves undersides (soffits), fitting air bricks to gable

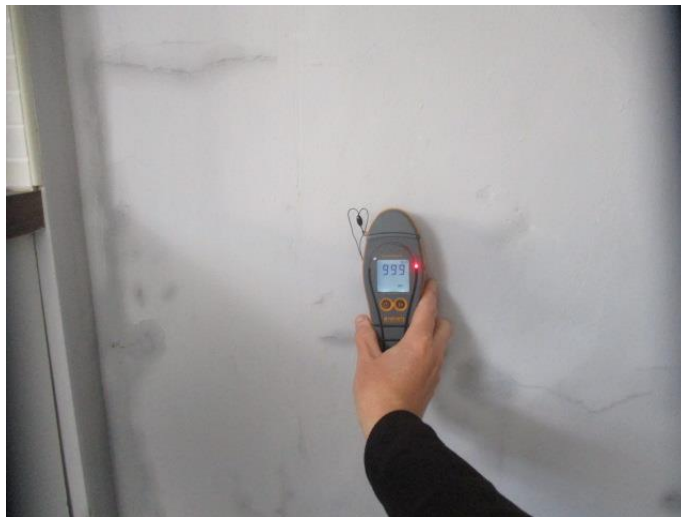
As noted in Section D4, rising dampness was noted to the majority of ground floor walls. The property has recently had a retro fitted chemical injected damp proof course installed with the associated replastering undertaken internally. It is not known if the new plaster is of Lime plaster which would allow the brickwork to breathe. Further investigation is now required. The walls to the understairs cupboard and righthand side wall of the kitchen have not been damp proofed and are damp. Further investigation is now required.

Damp to kitchen wall.

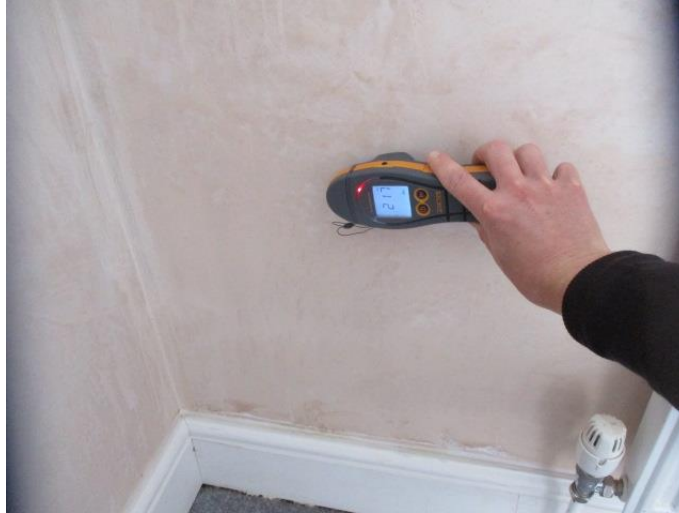
The damp proofing works were undertaken in February. Replastering to a height of approximately 1 metre has been undertaken internally. This is good practice. However, dampness was still noted on the damp meter to all ground floor walls. It is not known if a Lime plaster has been used as would be recommended. Further investigation via the original damp proofing firm should now be undertaken.

Damp to newly plastered wall.

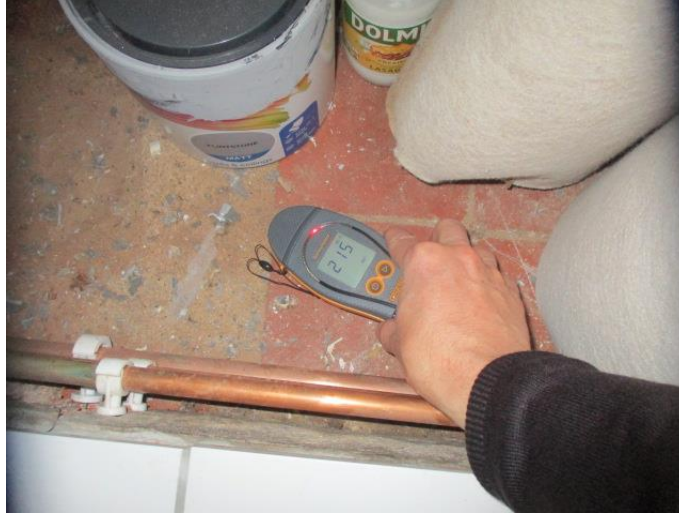
Solid floors to the understairs cupboard appear to be original and probably have no damp-proof membrane (DPM) to protect against dampness rising from the ground. Although some evidence of damp was found, the floors are an important feature of the property and the level of dampness is not felt to be sufficient to make lifting and re-laying of the floor surface above a DPM essential. Floors should not be surfaced with any impermeable covering such as vinyl or rubber-backed carpet (and ideally should be left exposed).

Damp to the floor in the under stairs cupboard.

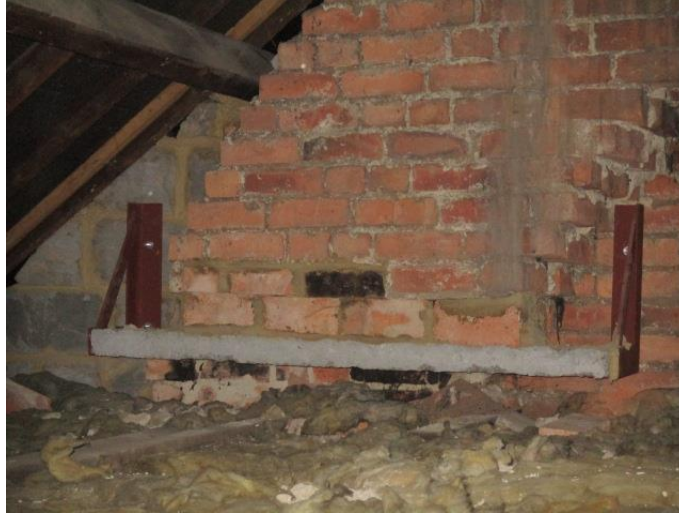
Support for removed chimney.

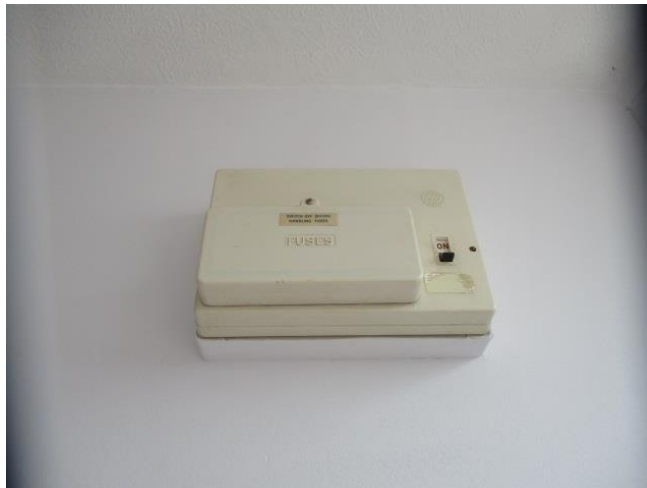
We have not carried out tests on the system. Based on our visual inspection there are a number of apparent shortcomings which indicate that at least some upgrading may be needed. These include the dated nature of some sockets and switches together with the dated fuse box. In addition, it is not known if the installation is covered by a current inspection and testing certificate.

Dated fusebox.

As such you should have the system tested now by a qualified electrician to ensure current wiring regulations including Part P of the Building Regulations are complied with. You should implement upgrading recommendations made in full.

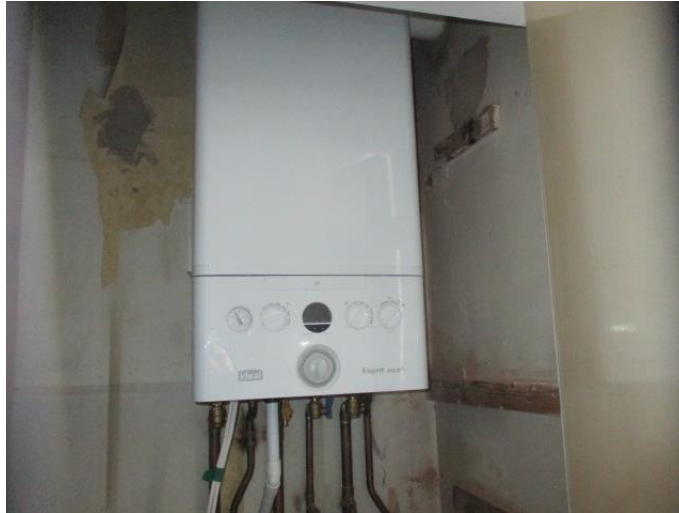
Boiler.

However, the service record has not been seen and as such you should have the system serviced by an engineer on the gas safe register (www.gassaferegister.co.uk) before a legal commitment to purchase. Annual servicing is recommended. Your Legal Advisers should enquire about the boiler service records. This advice can be lifted if recent satisfactory service/test documents are available.

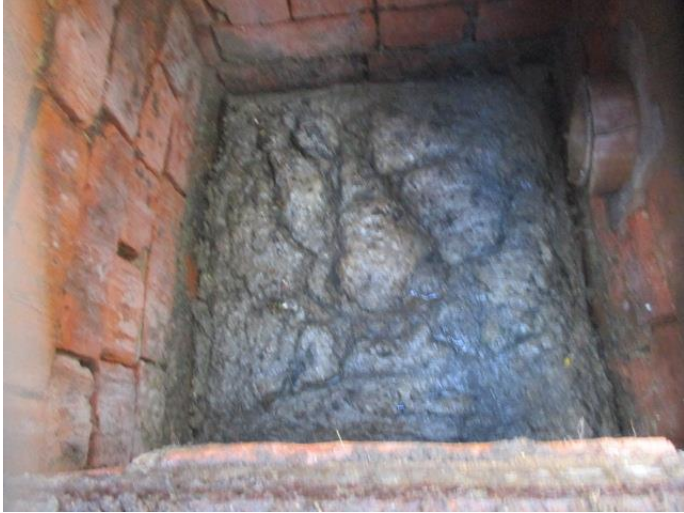
building of this age, there is a likelihood that drain defects will have developed, it should be appreciated that an inspection of the accessible manholes cannot conclusively confirm that other hidden areas are free from defect. This can only be established by a detailed drain test.

Blocked drains.

It is emphasised that a visual check of the drainage inspection chamber(s) will not confirm other parts of the drainage system are free from defects. There is a risk of defects to concealed areas. This risk must be accepted by you. If not, you should commission a full check in the form of a CCTV scan from a specialist drainage contractor.

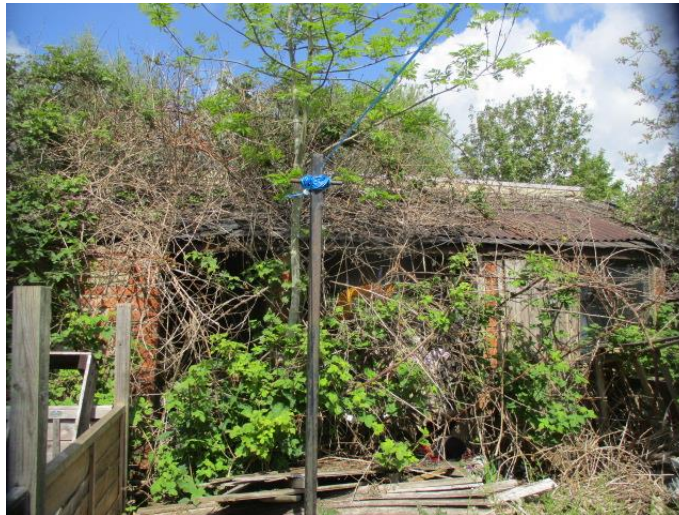
No access was available due to the overgrown nature surrounding the frontage. A comprehensive programme of repair and upgrading will be required. It may prove most cost effective to demolish the outbuildings.

Overgrown and dilapidated outbuildings.

Condition rating 3.

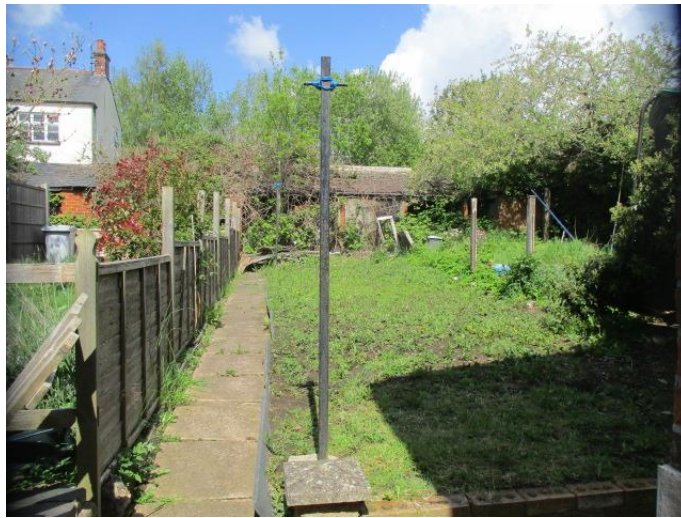
The fencing to the right-hand boundary is currently missing. This requires reinstating.

Missing fence.
